**NESHAP RENOVATION / DEMOLITION INSPECTION OF  
ASBESTOS CONTAINING MATERIALS  
AND OTHER HAZARDOUS WASTE MATERIALS  
FOR THE PROPERTY KNOWN AS:**

320 Wood St.  
Muskegon, MI 49442

January 11th, 2016

ETC Job #: 177224

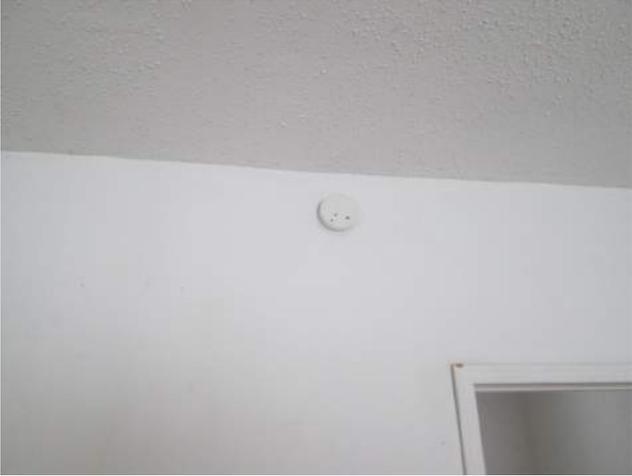
Material #	Material Description	Quantity	Location
1	Smoke Detector	1	Living Room

Hazard: Smoke detector .

- Chart B – Is a list of other hazardous materials (above RCRA household quantity levels) that will require special handling and disposal by the contractor.
