**NESHAP RENOVATION / DEMOLITION INSPECTION OF  
ASBESTOS CONTAINING MATERIALS  
AND OTHER HAZARDOUS WASTE MATERIALS  
FOR THE PROPERTY KNOWN AS:**

1327 Montgomery  
Muskegon, MI

January 15th, 2016

ETC Job #: 177226

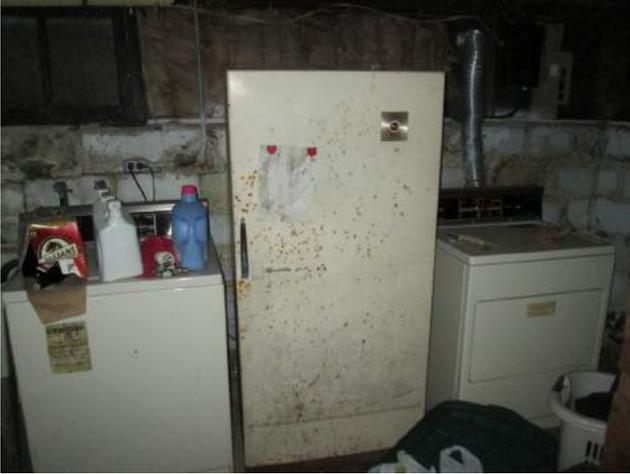
Hazard: refrigerator

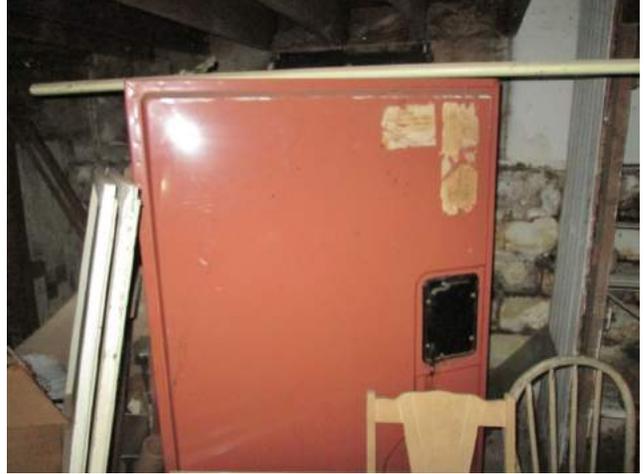
Hazard :Freezer

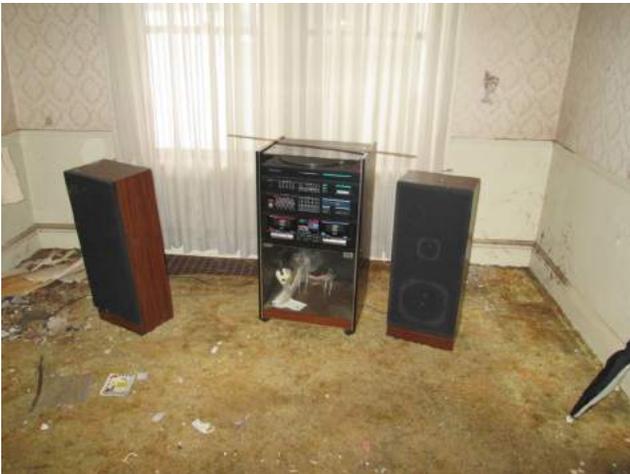
Hazard : Stereo

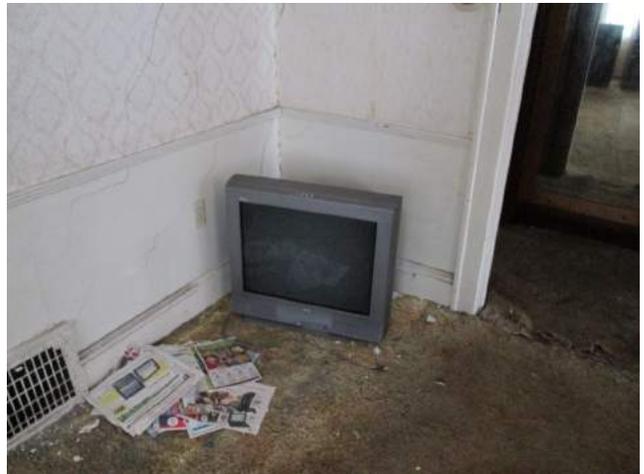
Hazard, Television.

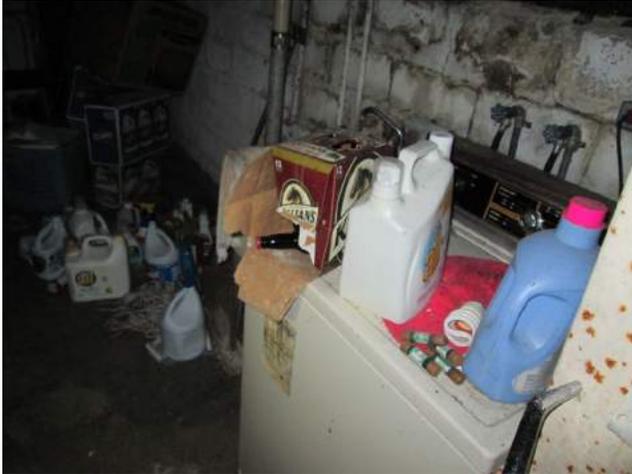
Hazard : Cleaners

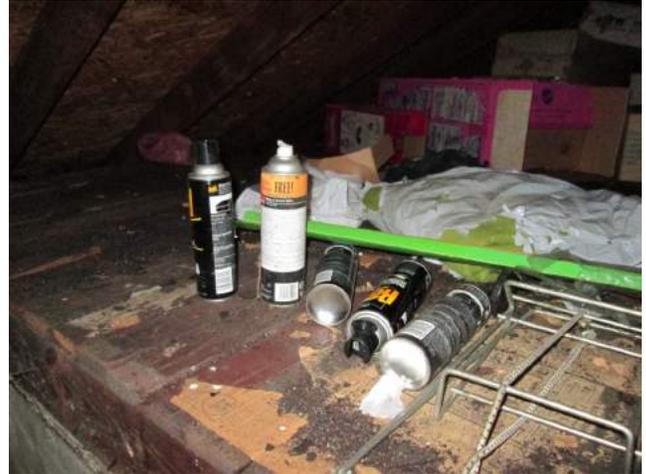
Hazard : Bug Killer

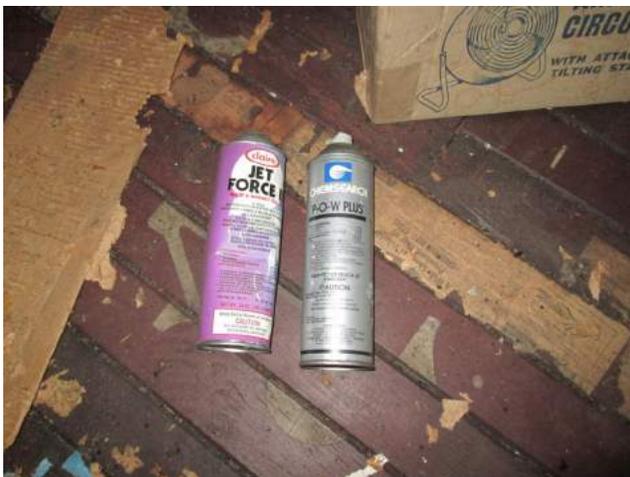
Hazard: Aerosol's

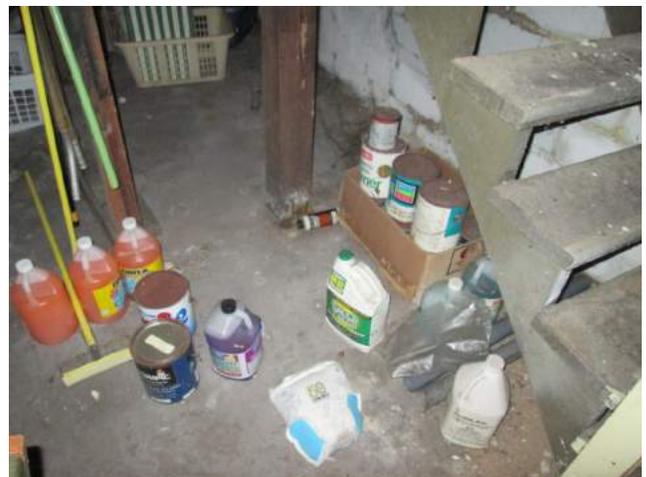
Hazard : Aerosols and cleaners

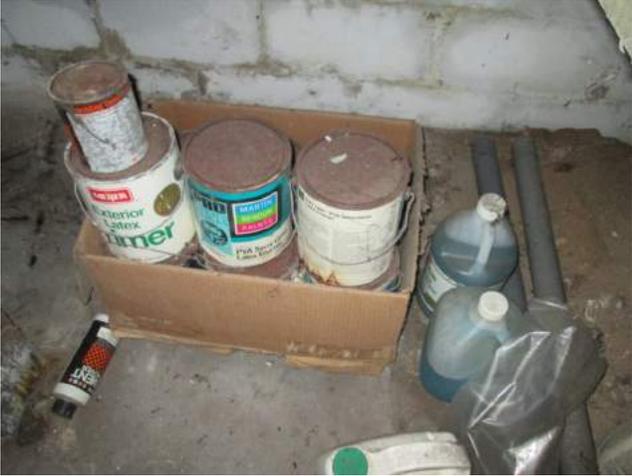
Hazard: Paint Can's

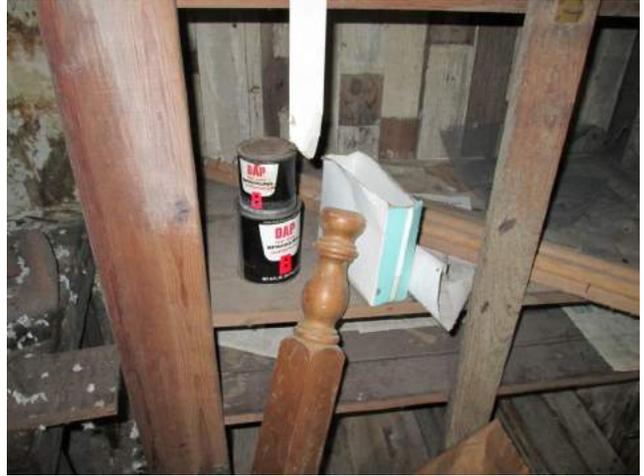
Hazard :Paint Can's

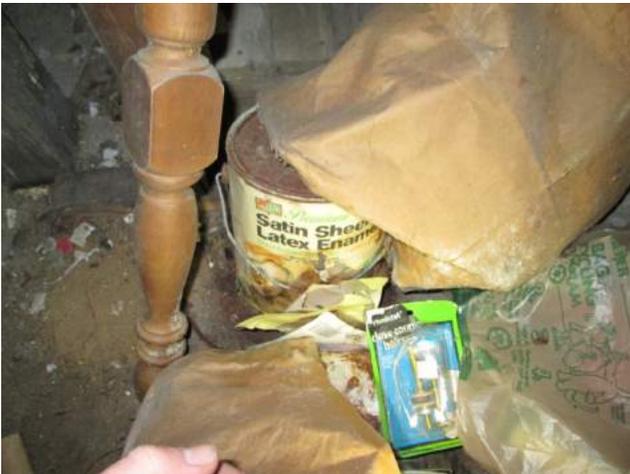
Hazard : Paint Can's

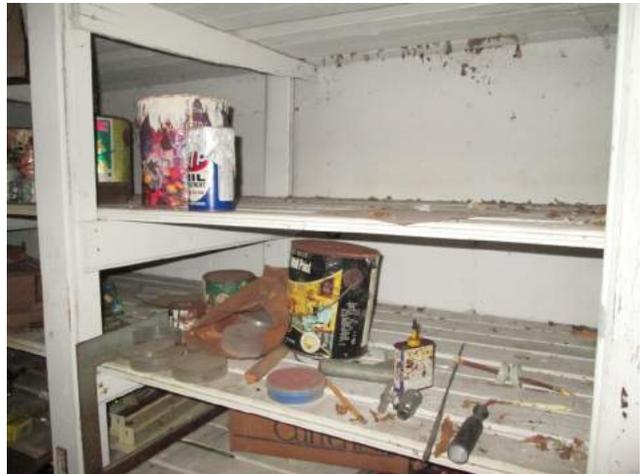
Hazard: Paint Can's

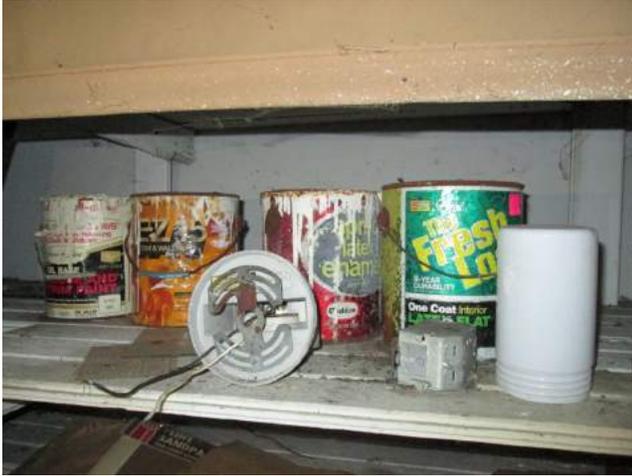
Hazard: Paint Can's

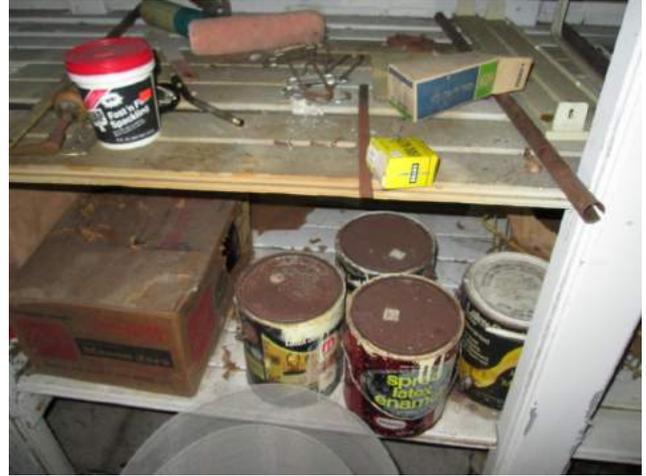
Hazard :Paint Can's

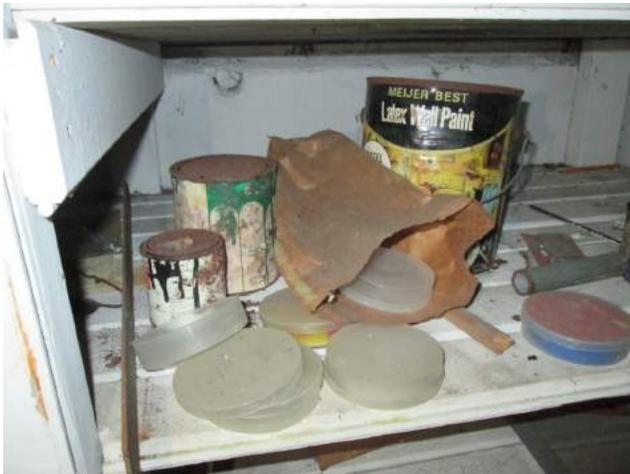
Hazard : Paint Can's

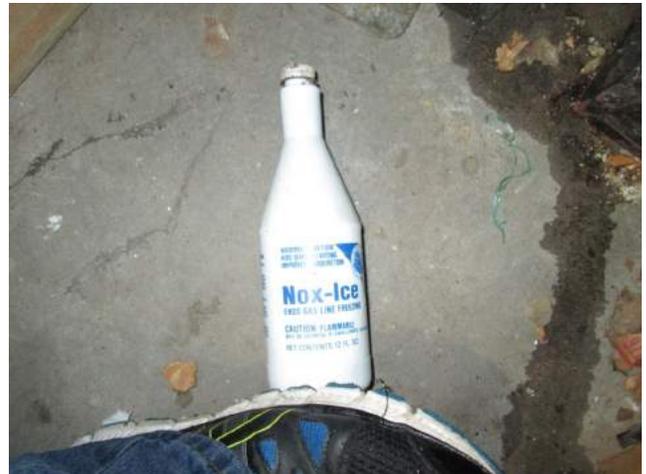
Hazard: Aerosol

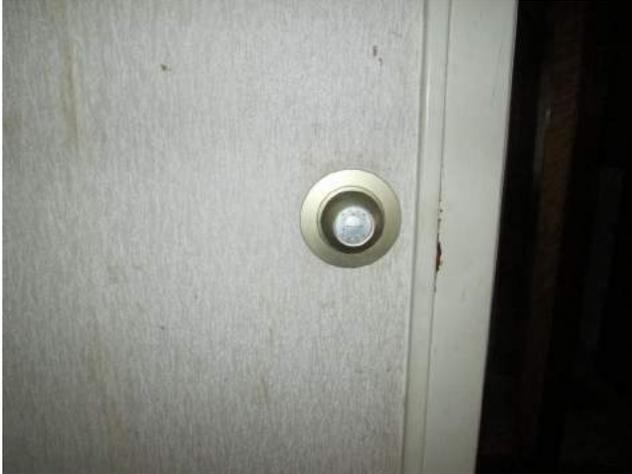
Hazard: Thermostat

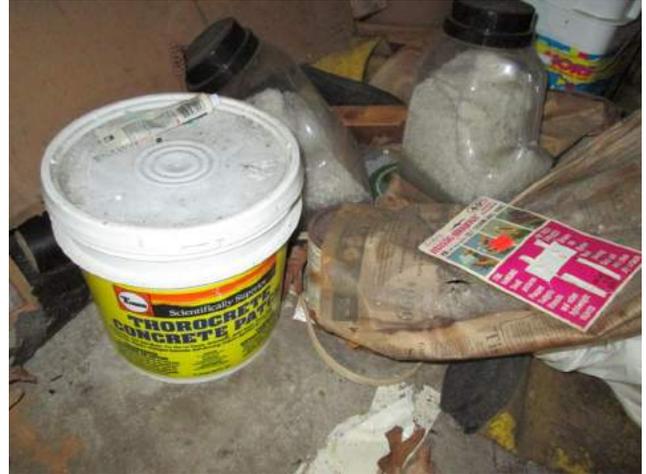
Hazard :Concrete Patching.

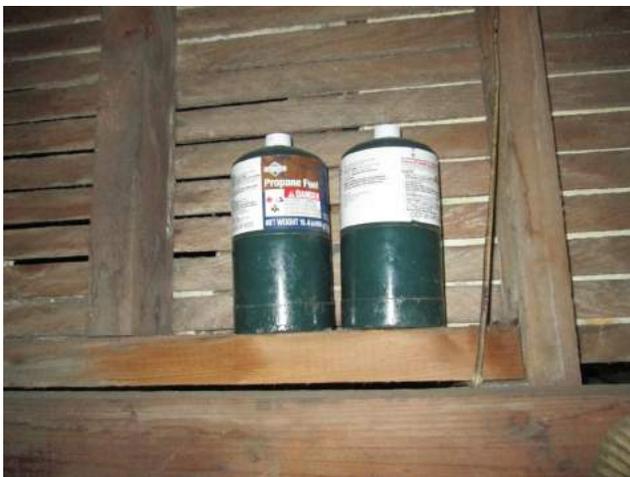
Hazard : Propane tanks

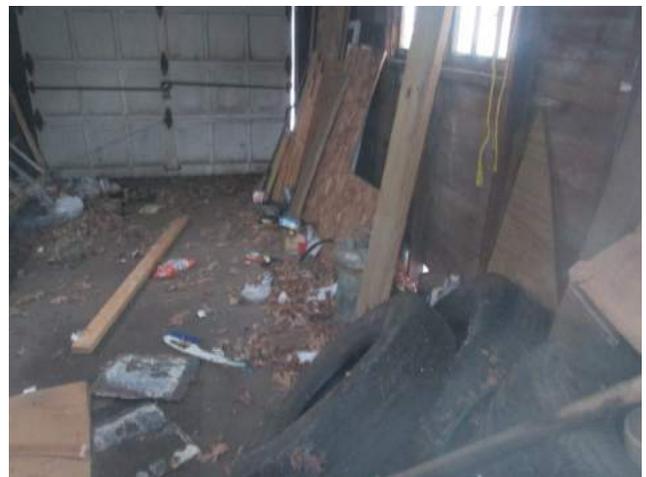
Hazard: Gas Can

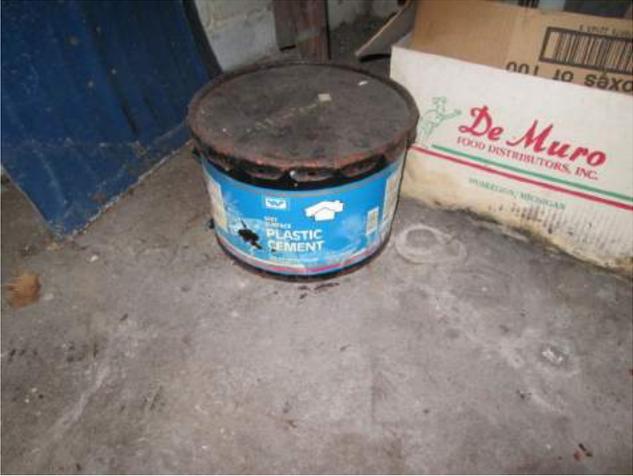
Hazard: Roof Cement
