**NESHAP RENOVATION / DEMOLITION INSPECTION OF
ASBESTOS CONTAINING MATERIALS
AND OTHER HAZARDOUS WASTE MATERIALS
FOR THE PROPERTY KNOWN AS:**

1357 7th St.
Muskegon, MI 49441

January 20th, 2016

ETC Job #: 177232

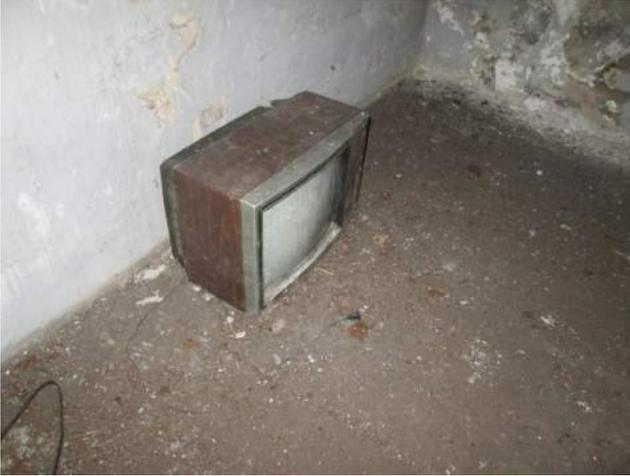
Hazard : TV, Basement

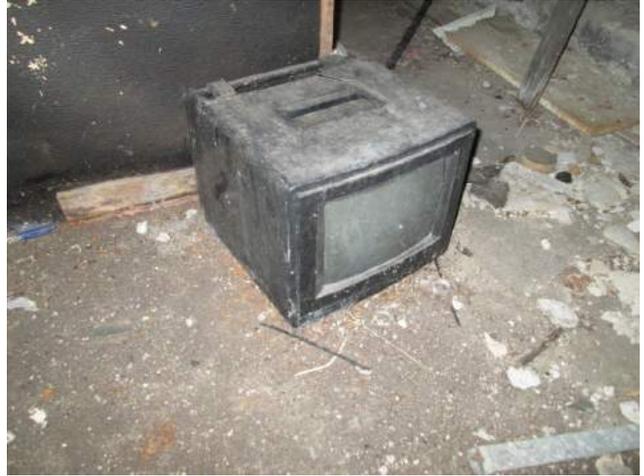
Hazard : TV, Basement

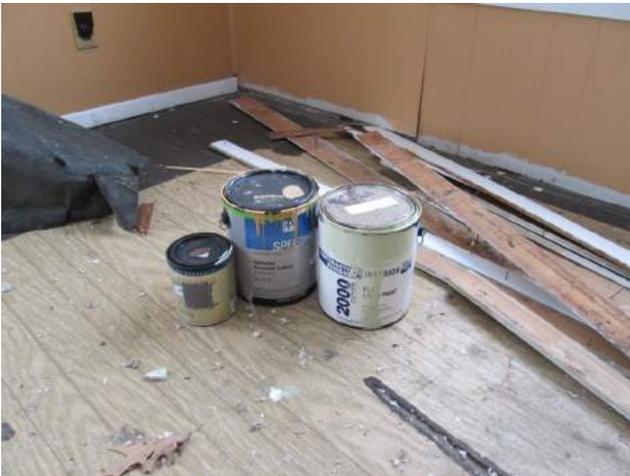
Hazard: Paint Can's, Bed 9

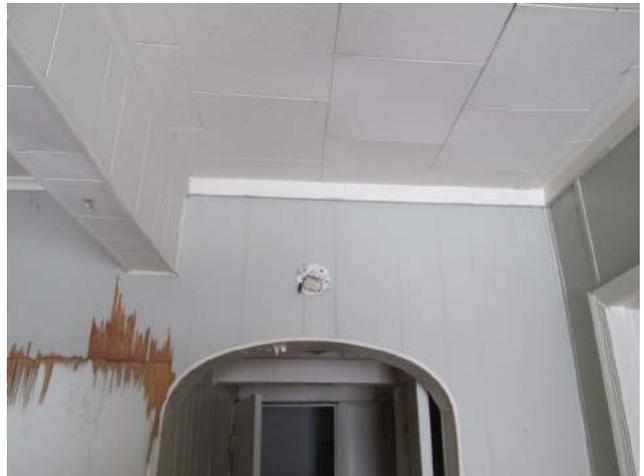
Hazard: Smoke Detector

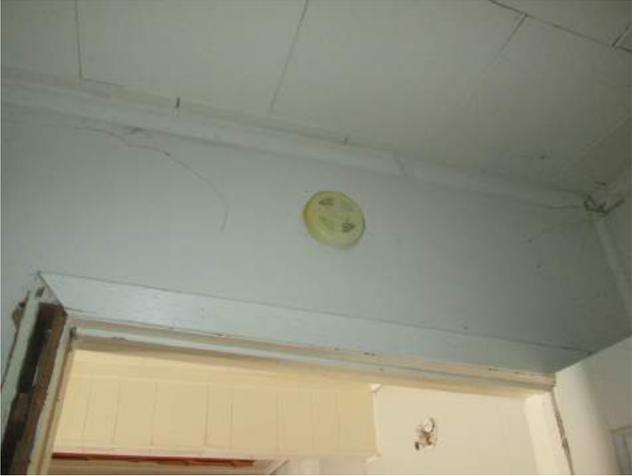
Hazard: Smoke Detector

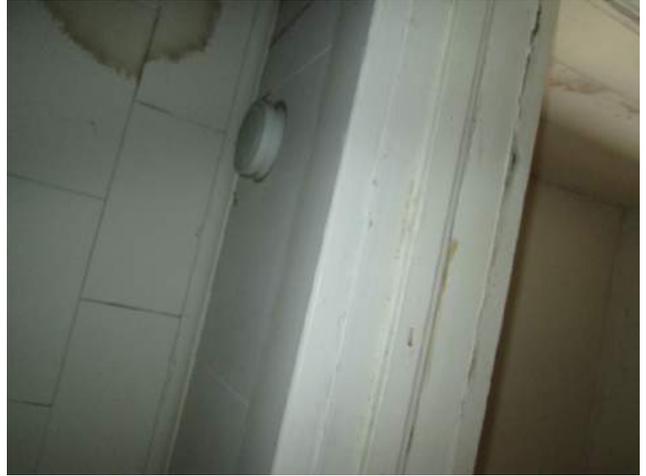
Hazard: Smoke Detector

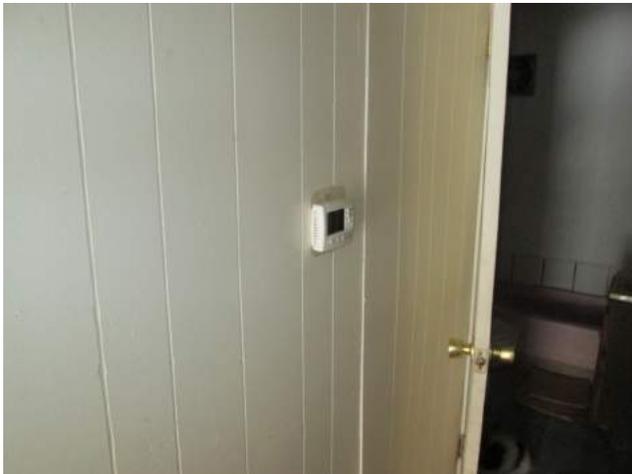
Hazard: Thermostat

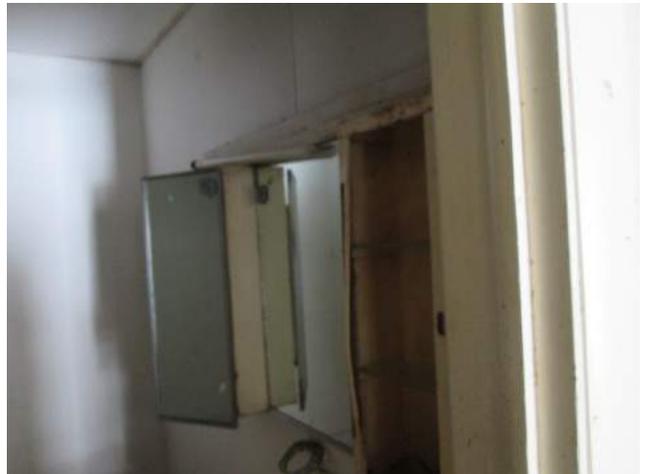
Hazard : Fluorescent Light Bulb
