**NESHAP RENOVATION / DEMOLITION INSPECTION OF
ASBESTOS CONTAINING MATERIALS
AND OTHER HAZARDOUS WASTE MATERIALS
FOR THE PROPERTY KNOWN AS:**

1445 Park St.
Muskegon, MI 49441

02/09/2016

ETC Job #: 177237

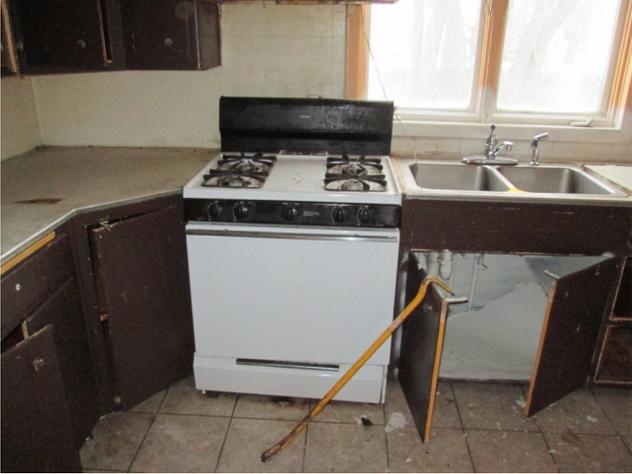
Hazard : Stove /Oven

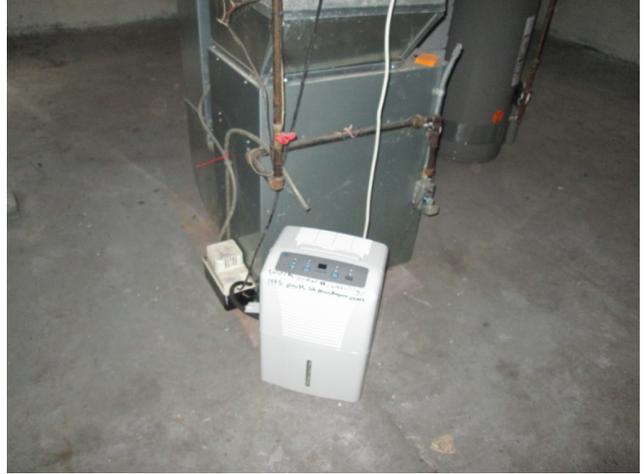
Hazard : Dehumidifier

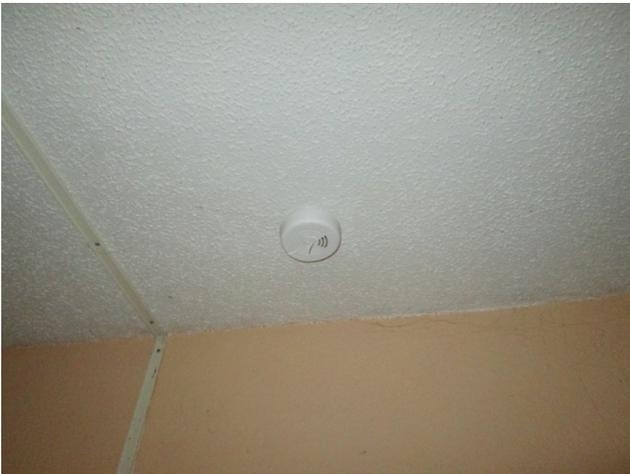
Hazard : Smoke Detector

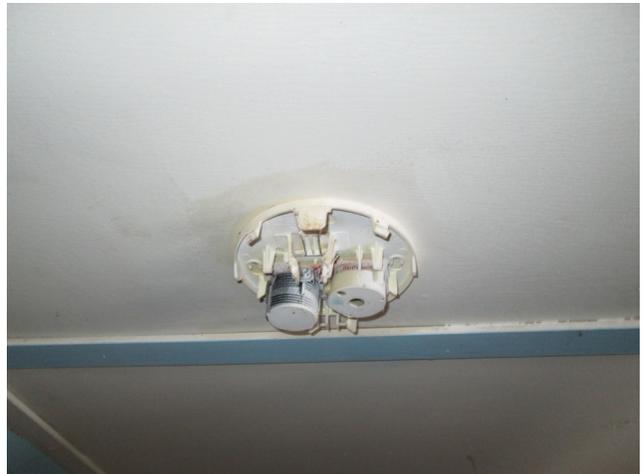
Hazard : Smoke Detector

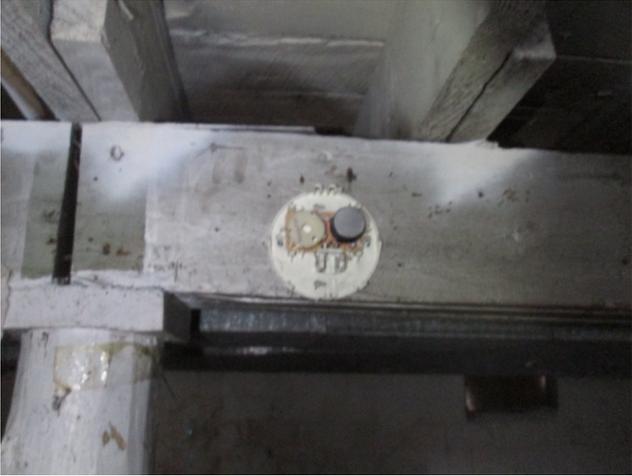
Hazard : Smoke Detector

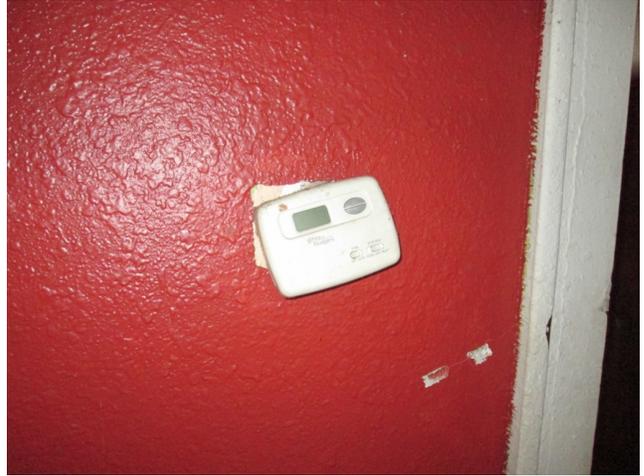
Hazard : Thermostat

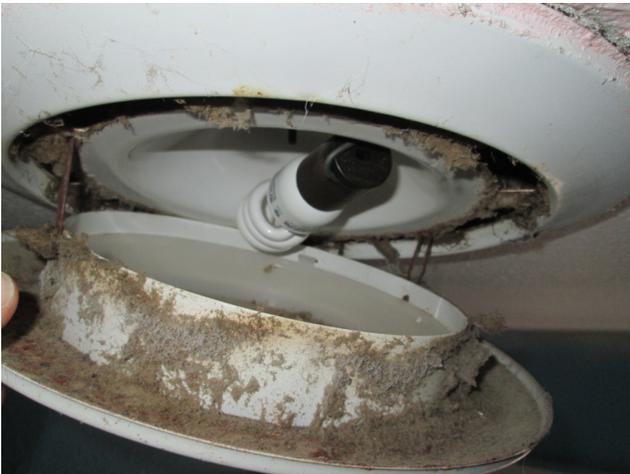
Hazard : Florescent Light Bulbs

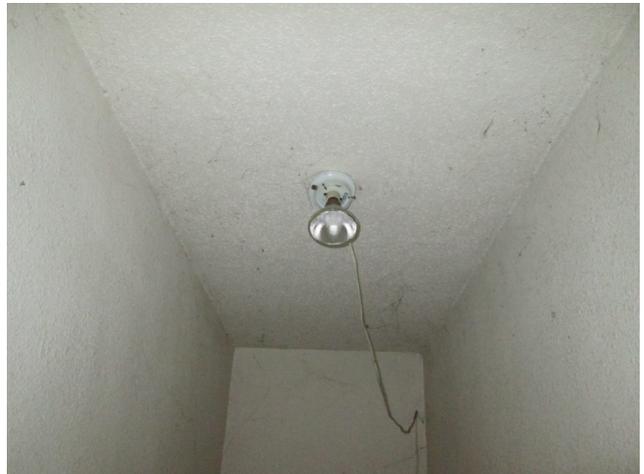
Hazard : Florescent Light Bulbs

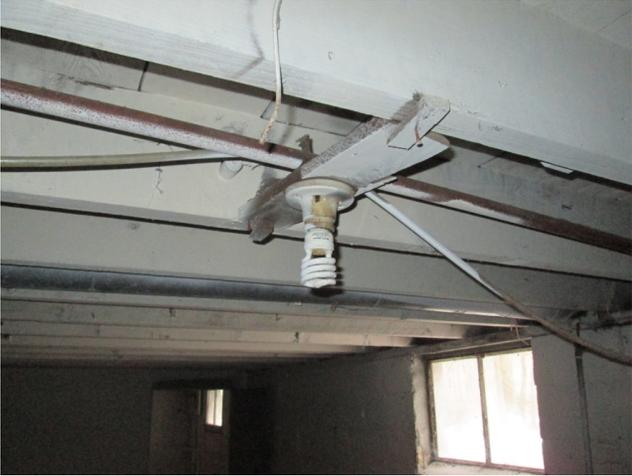
Hazard : Florescent Light bulbs
