**NESHAP RENOVATION / DEMOLITION INSPECTION OF
ASBESTOS CONTAINING MATERIALS
AND OTHER HAZARDOUS WASTE MATERIALS
FOR THE PROPERTY KNOWN AS:**

1535 6th Street
Muskegon, MI 49441

January 11th, 2016

ETC Job #: 177218

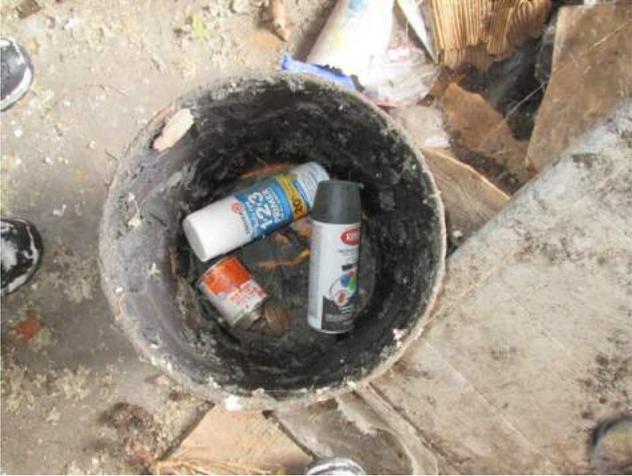
Material #	Material Description	Quantity	Location
1	Spray Can's.	2	Room 15
2	Glue Can, Pint	1	Room 15
3	Gallon paint	1	Room 17
4	Smoke Detector	2	Rooms 6 and 11
5	Thermostat	1	Room 11

Hazard: spray cans and glue can.

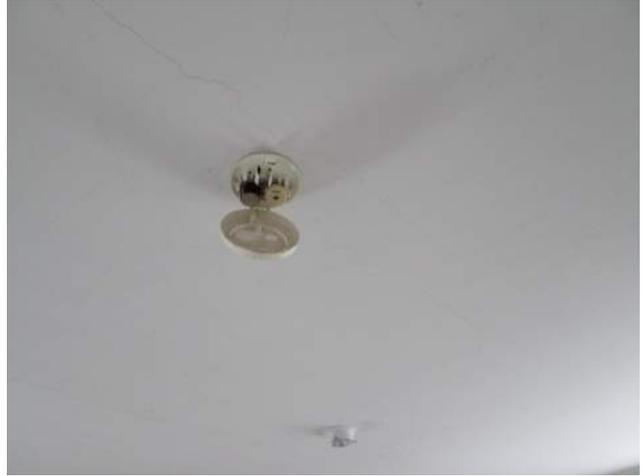
Hazard :Smoke detector 1

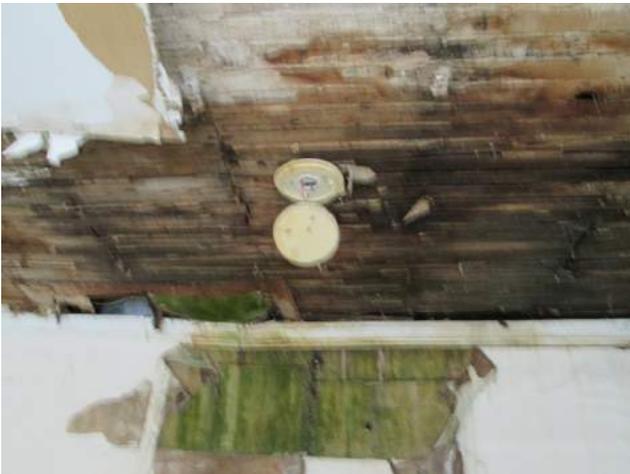
Hazard : Smoke detector 2

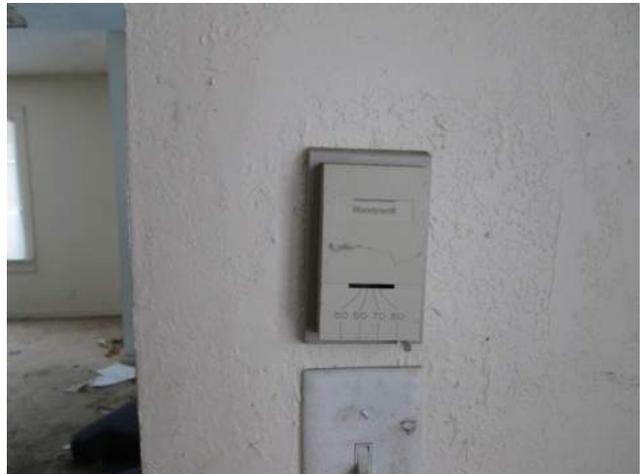
Hazard: Thermostat

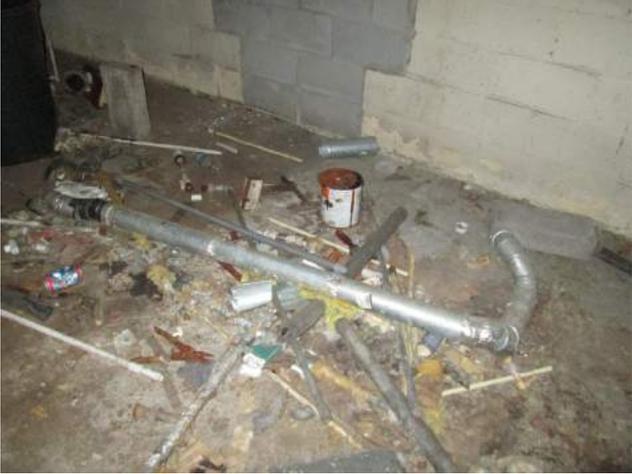
Hazard: Paint can.
