**NESHAP RENOVATION / DEMOLITION INSPECTION OF  
ASBESTOS CONTAINING MATERIALS  
AND OTHER HAZARDOUS WASTE MATERIALS  
FOR THE PROPERTY KNOWN AS:**

333 Mason  
Muskegon, MI 49441

02/09/2016

ETC Job #: 177239

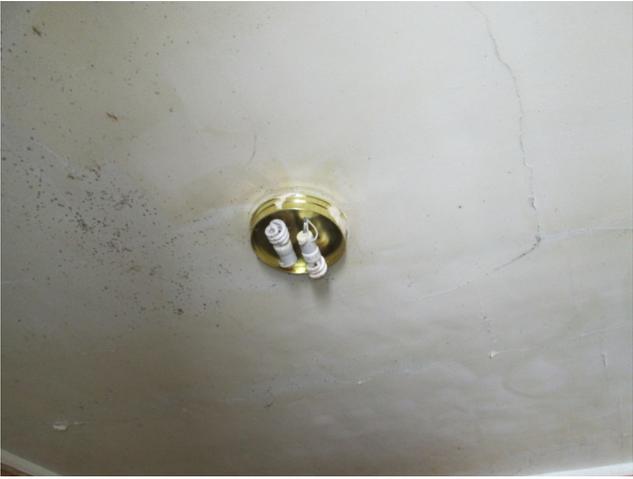
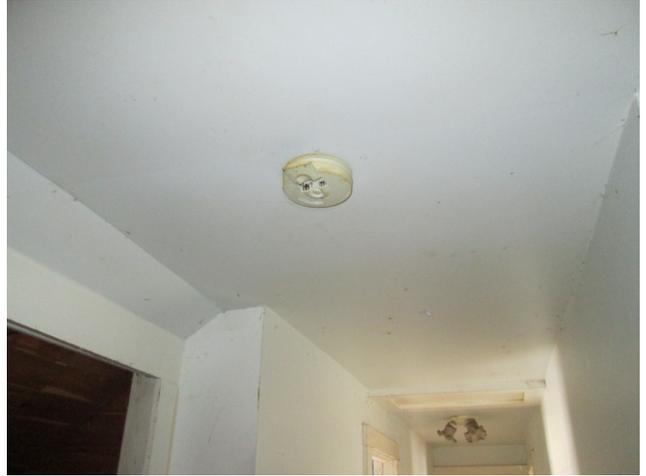
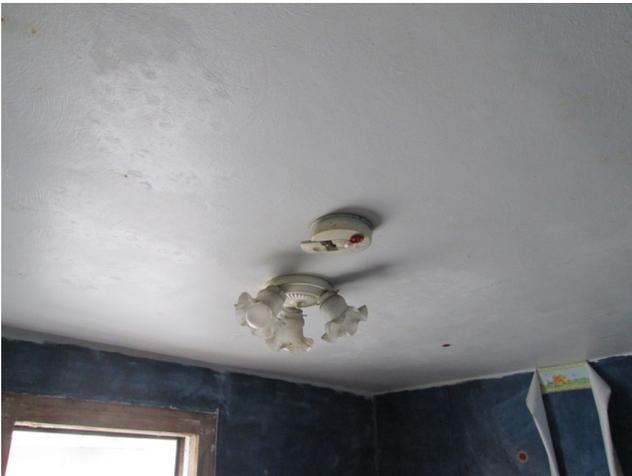
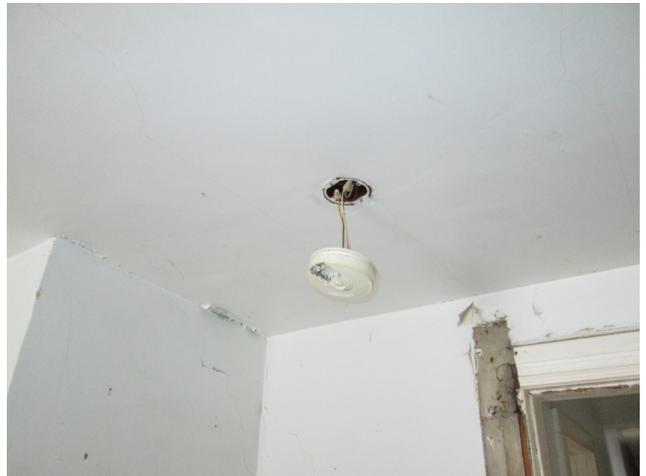
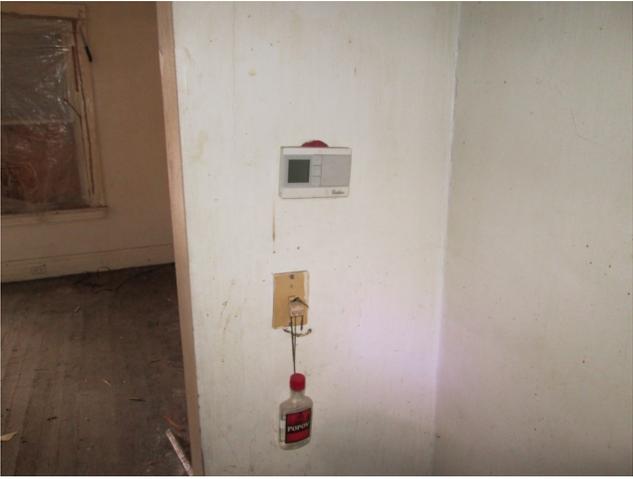
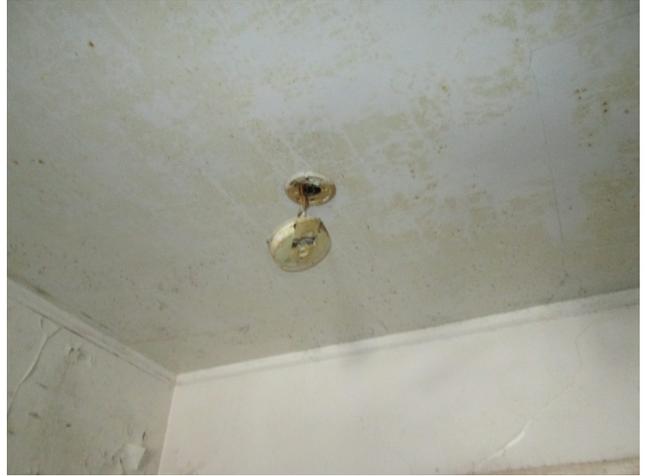
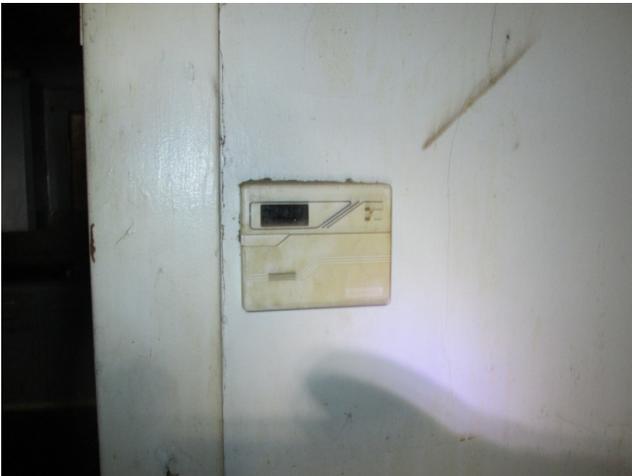
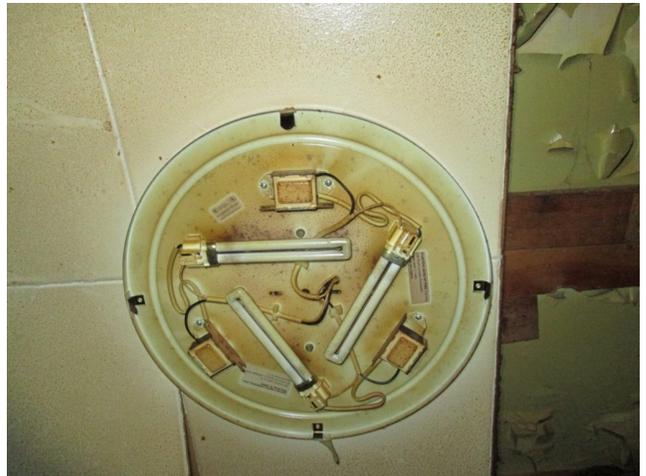
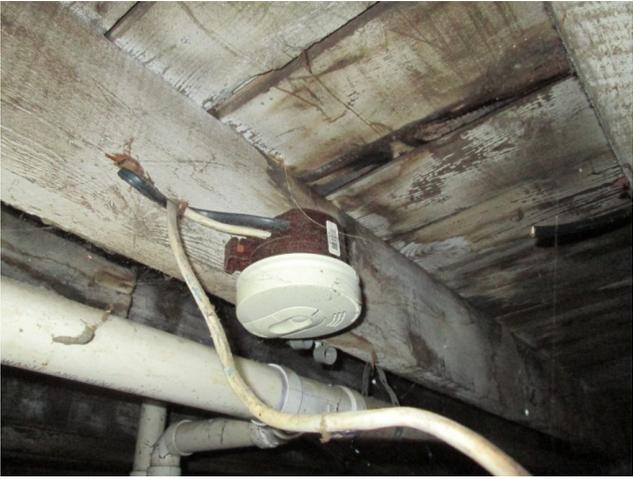
Material #	Material Description	Quantity	Location
1	Smoke Detectors	6	Rooms 4, 6-8 & 16
2	Thermostat	2	Room 9
3	Florescent Light Bulbs, CFL's 2; 4" Rectangle Bulbs 3	5	Room 1

- Chart B – Is a list of other hazardous materials (above RCRA household quantity levels) that will require special handling and disposal by the contractor.
