**NESHAP RENOVATION / DEMOLITION INSPECTION OF  
ASBESTOS CONTAINING MATERIALS  
AND OTHER HAZARDOUS WASTE MATERIALS  
FOR THE PROPERTY KNOWN AS:**

357 Mason  
Muskegon, MI 49441

02/09/2016

ETC Job #: 177233

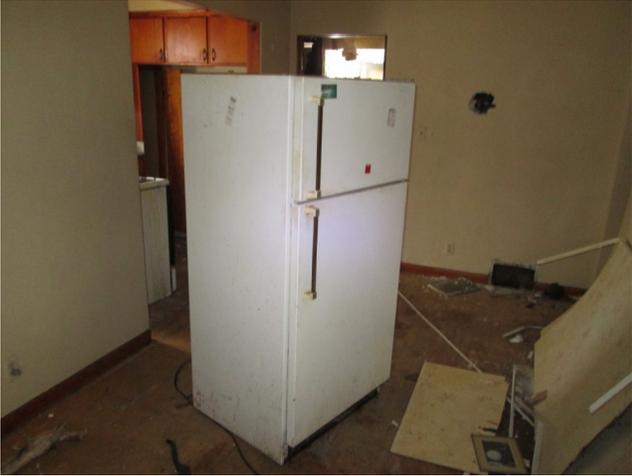
Hazards : Refrigerator

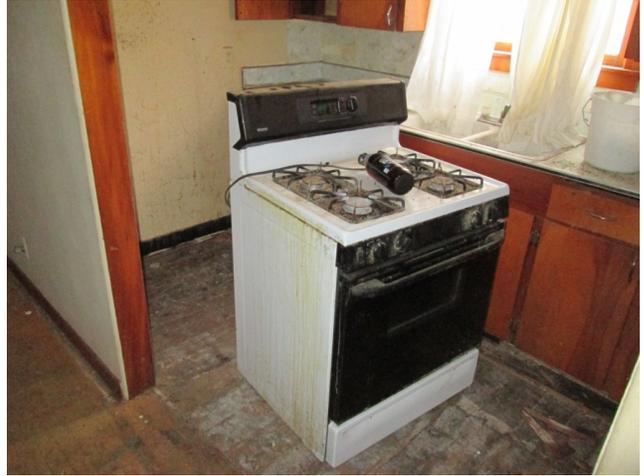
Hazard : Stove

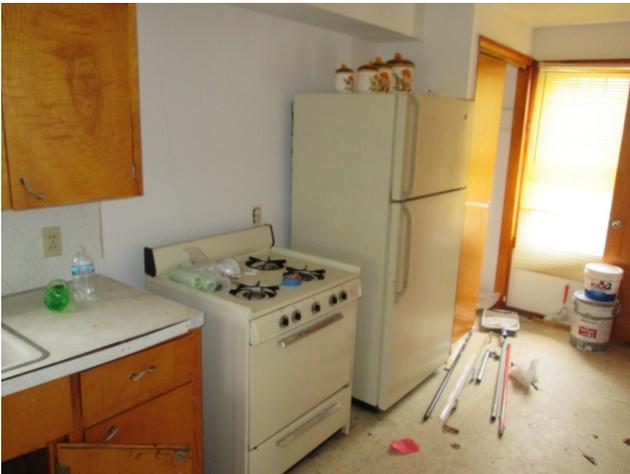
Hazard: Stove

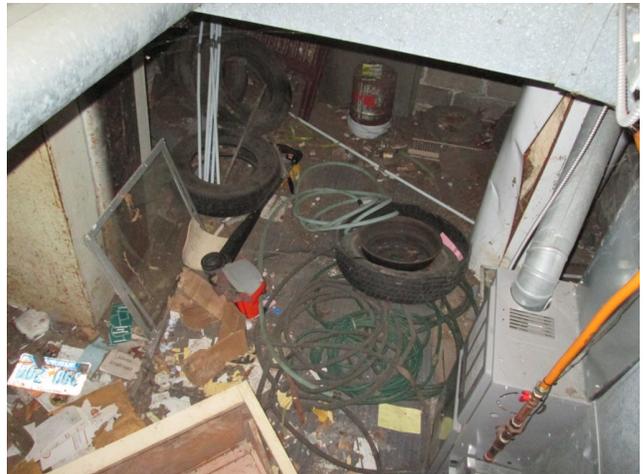
Hazard: Electronics

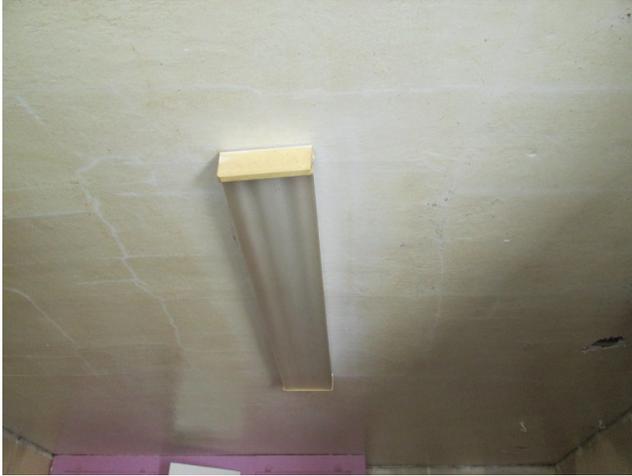
Hazard :Florescent light ballast

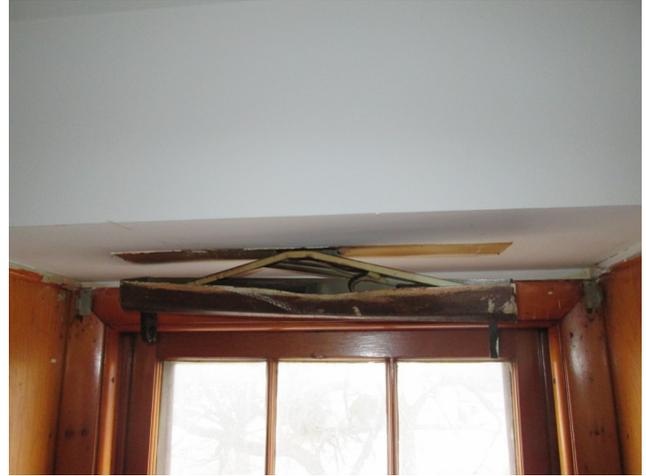
Hazard : Florescent Light ballast

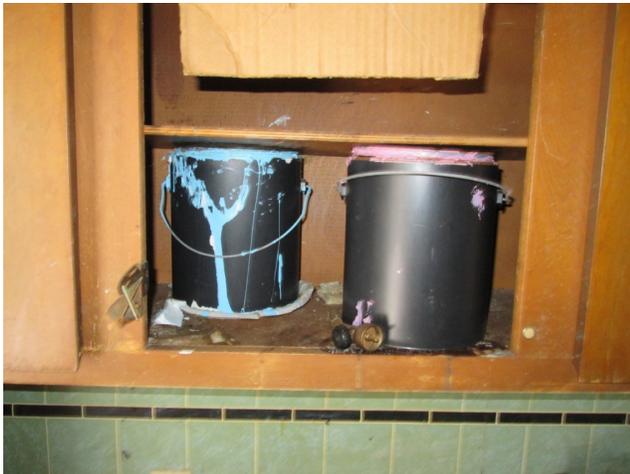
Hazard : Paint Cans

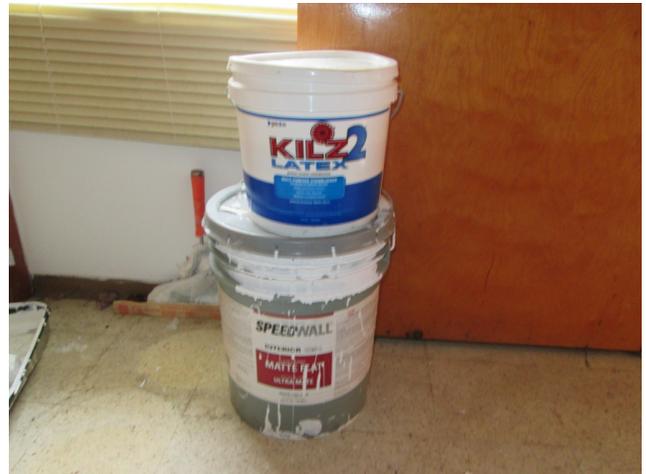
Hazard : Paint Cans

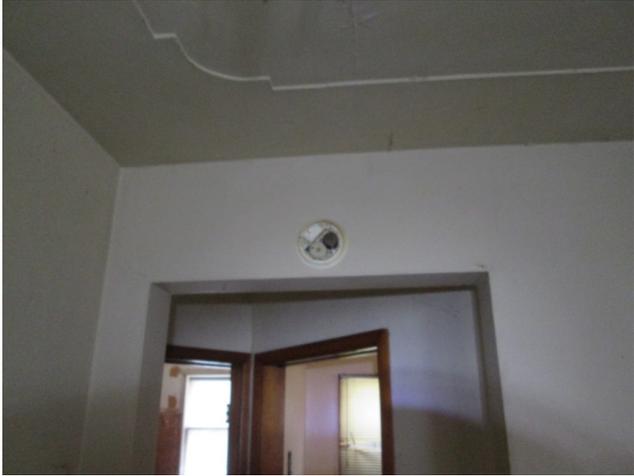
Hazard : Smoke Detector

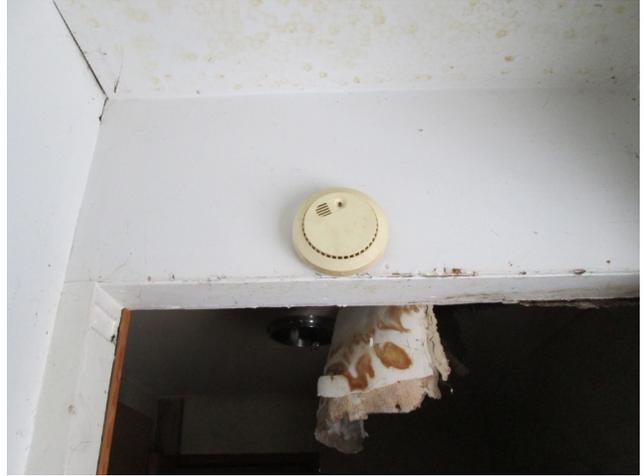
Hazard : Smoke Detector

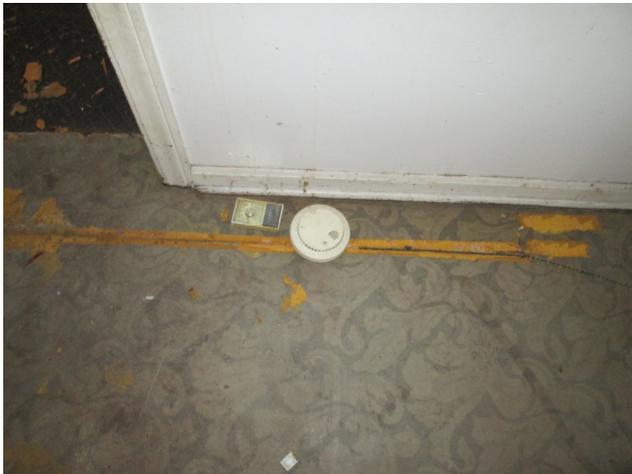
Hazard : Smoke Detector

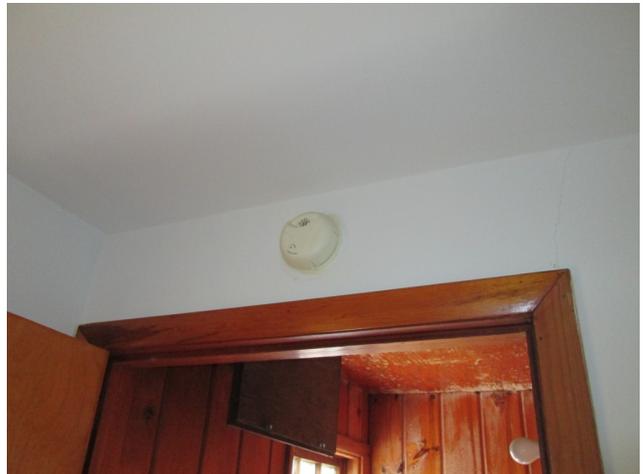
Hazard : Smoke Detector

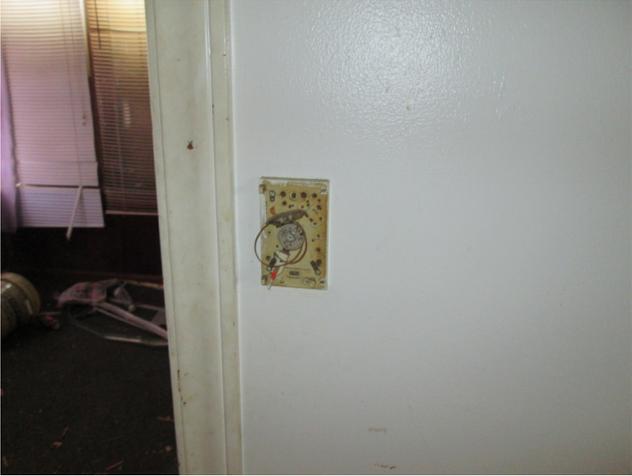
Hazard : Thermostat

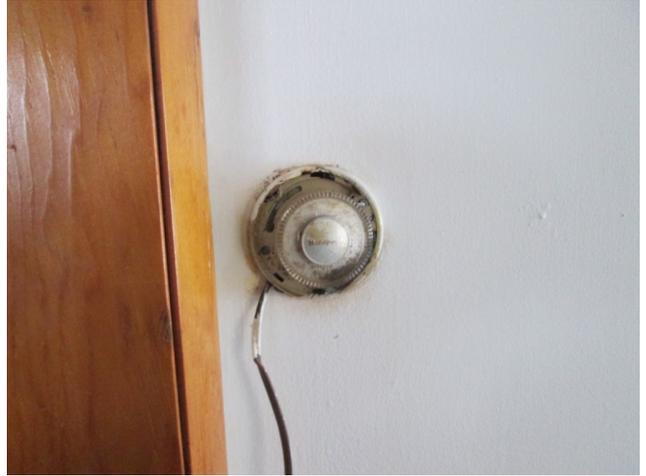
Hazard : Thermostat

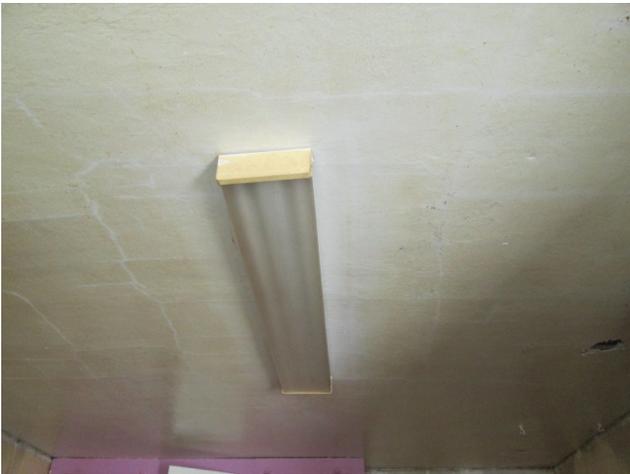
Hazard: Florescent Light

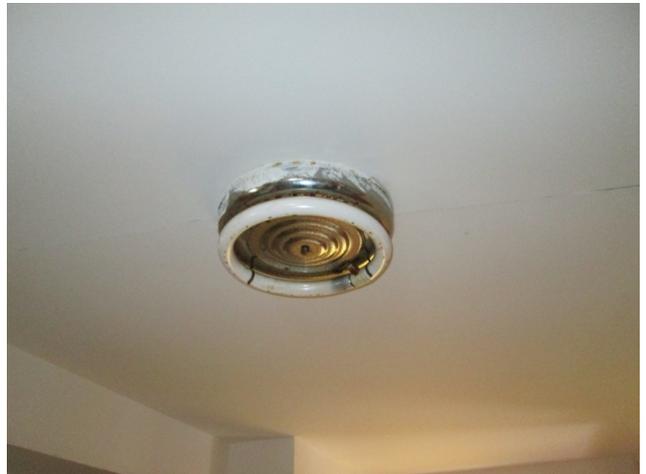
Hazard: Florescent Light

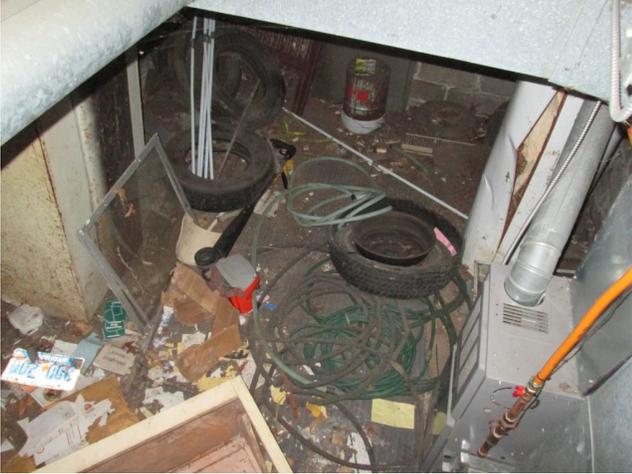
Hazard :Car Tires

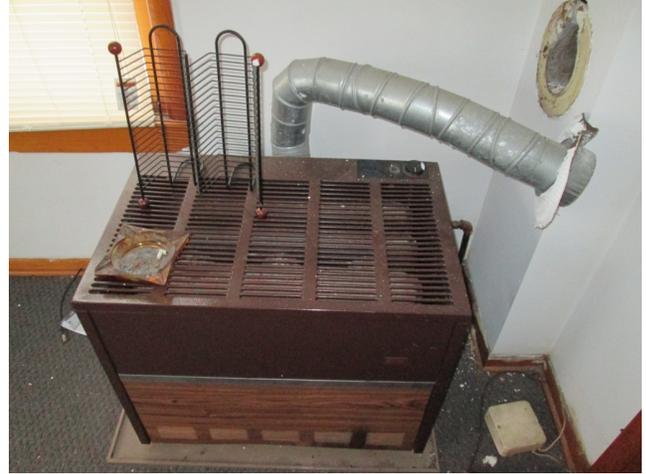
Hazard: Gas Heater

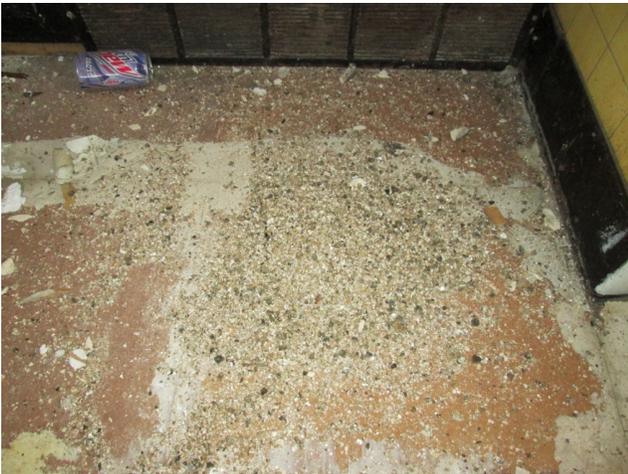
Assumed Positive : Vermiculite

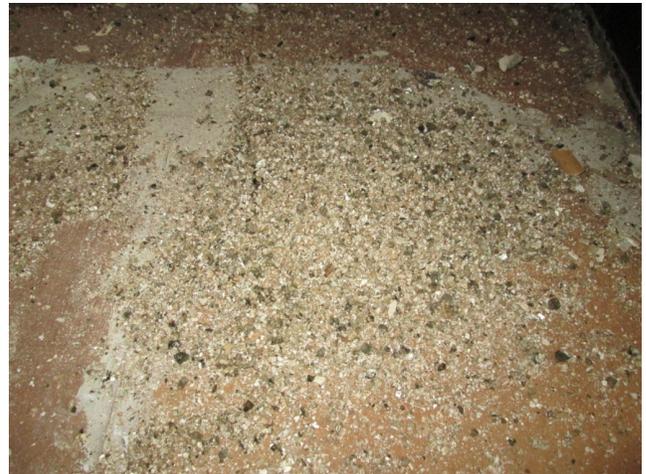
Assumed Positive : Vermiculite (2)

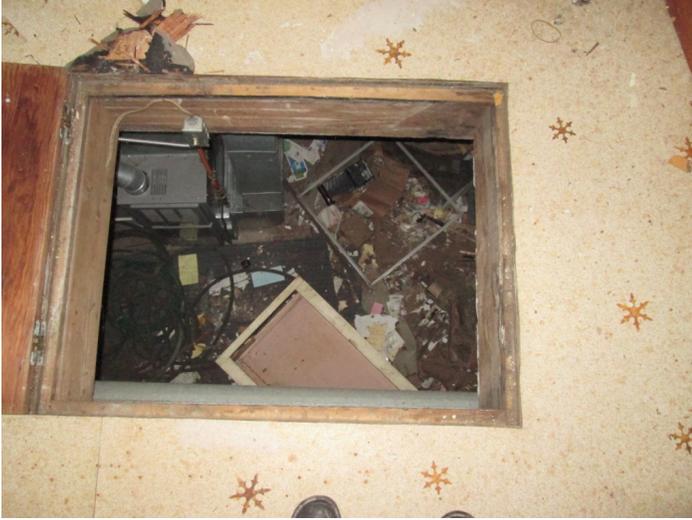
Floor Hatch to Basement—Inaccessible.
