**NESHAP RENOVATION / DEMOLITION INSPECTION OF
ASBESTOS CONTAINING MATERIALS
AND OTHER HAZARDOUS WASTE MATERIALS
FOR THE PROPERTY KNOWN AS:**

407 Marquette
Muskegon, MI 49442

02/08/2016

ETC Job #: 177230

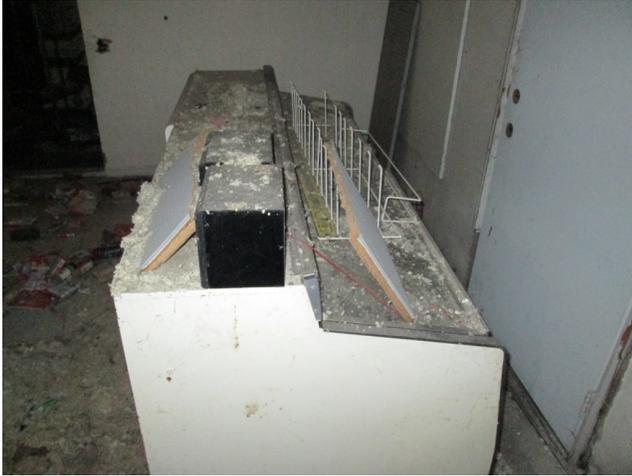
Hazard : Refrigerator /Stero

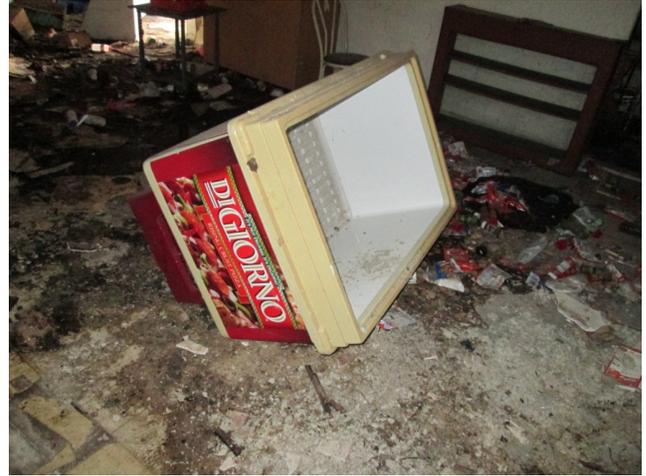
Hazard : Refrigerator

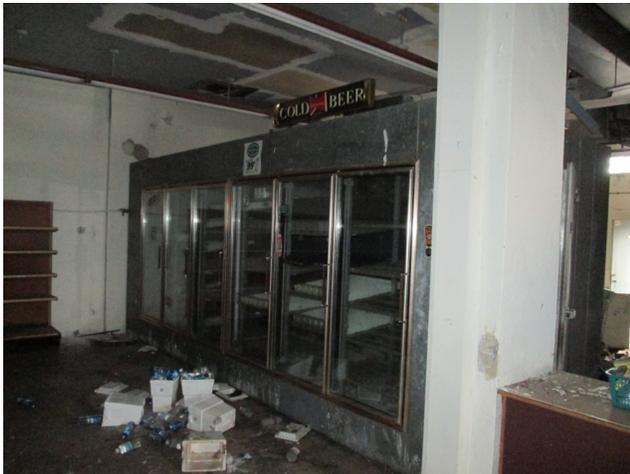
Hazard : Refrigerator

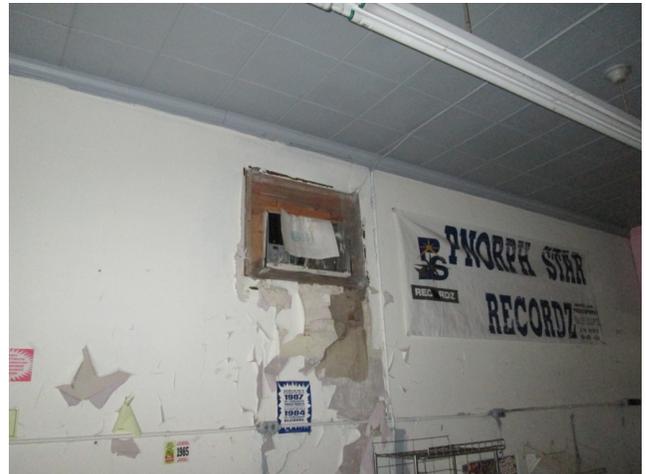
Hazard: Air Conditioner

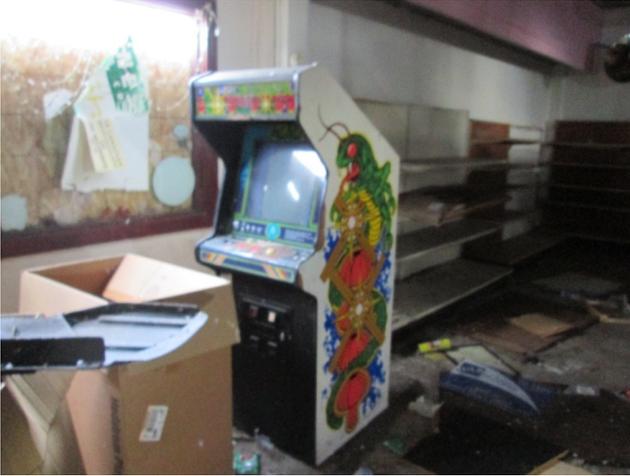
Hazard : Centipede Arcade Game

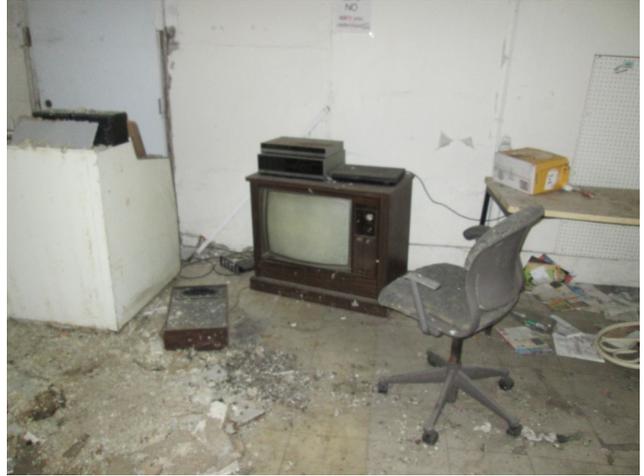
Hazard: Television

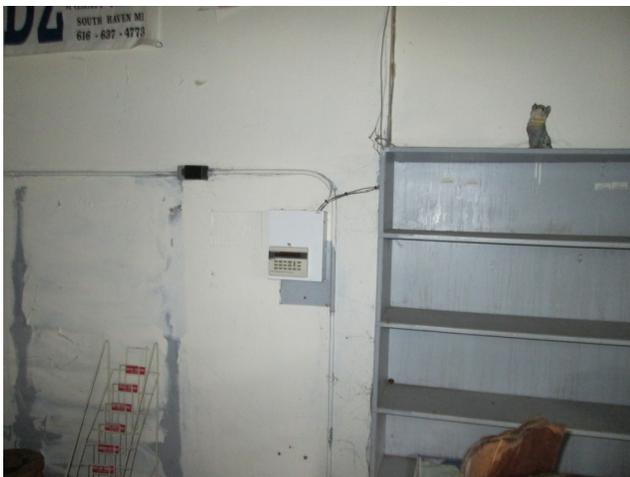
Hazard : Security system

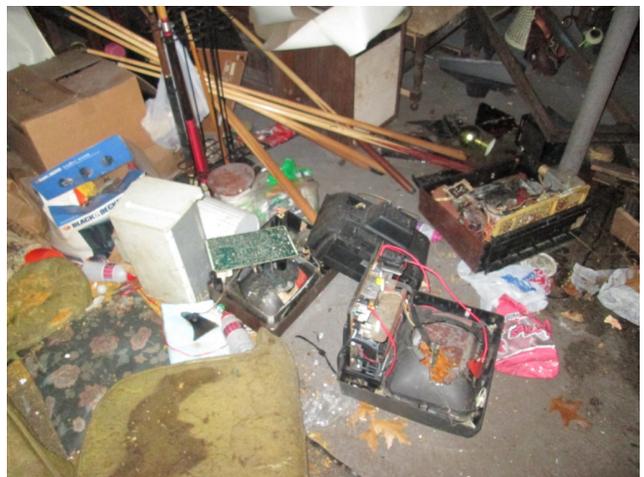
Hazard : Misc Electronics

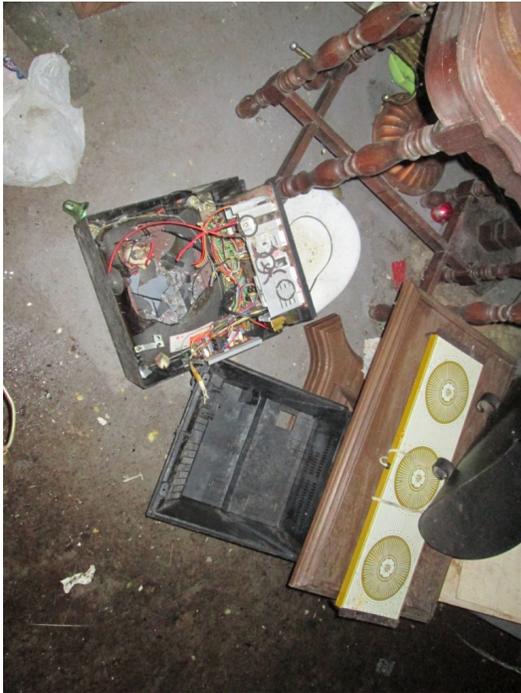
Hazard : Misc Electronics

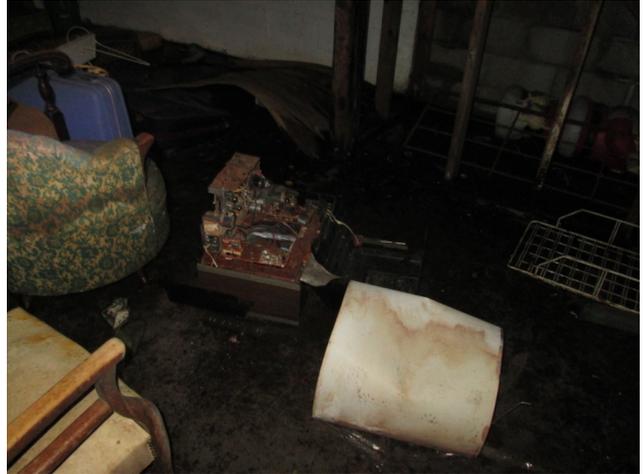
Hazard : Misc Electronics

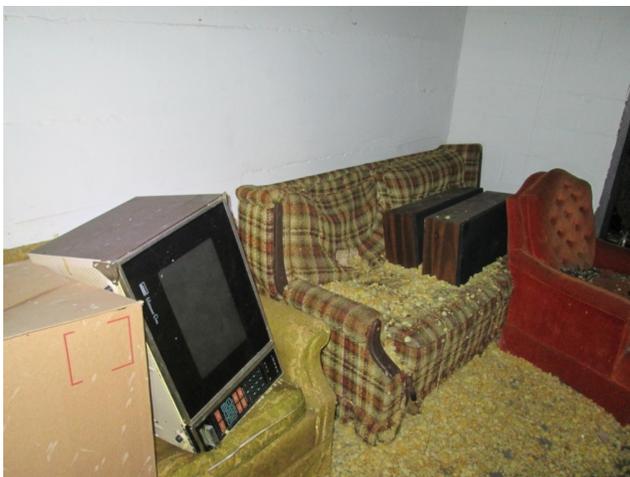
Hazard: Misc Electronics

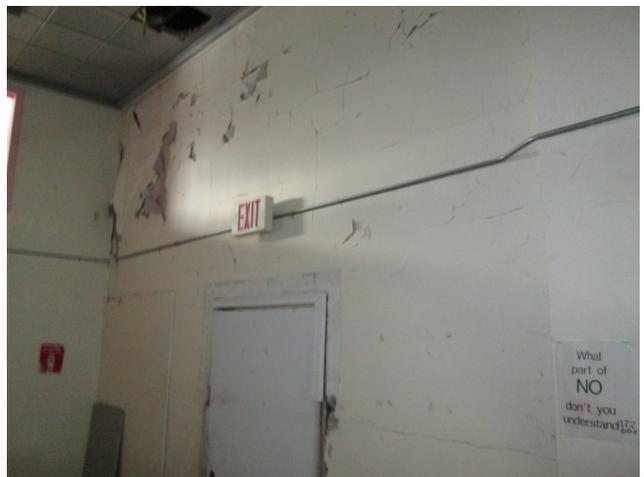
Hazard : Ext Sign

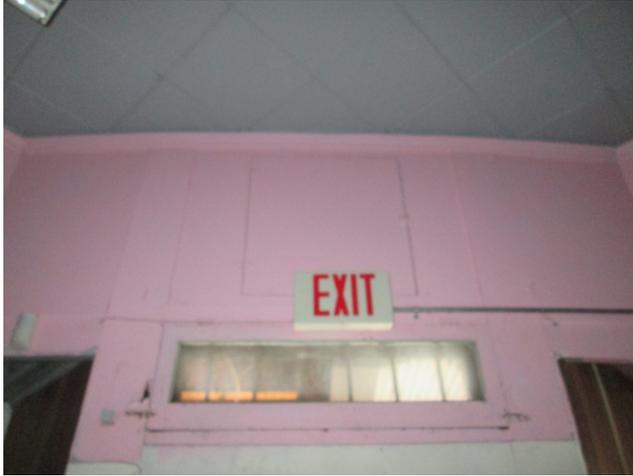
Hazard : Exit Sign

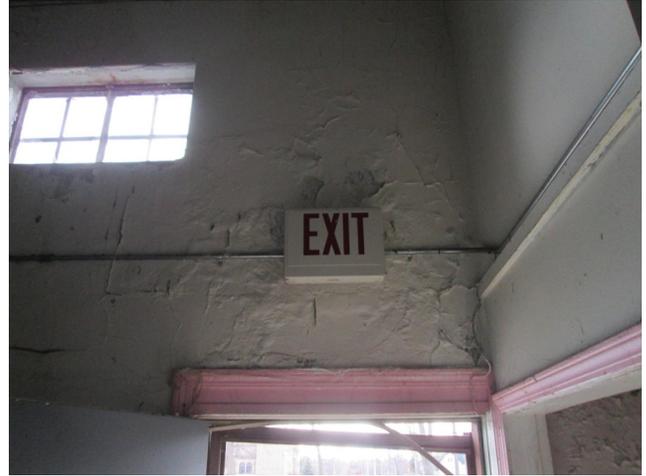
Hazard :Exit Sign

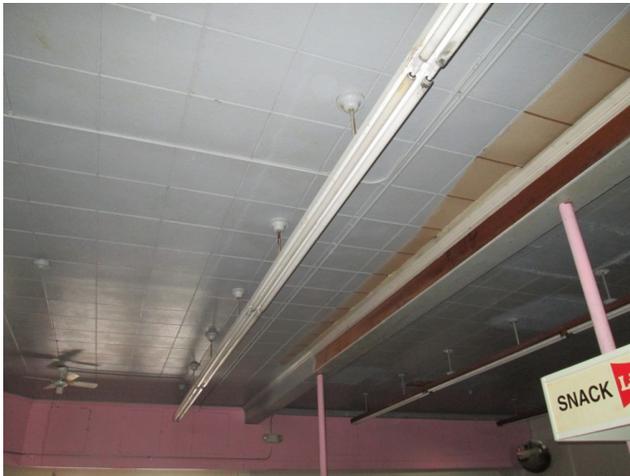
Hazard: Light Ballasts

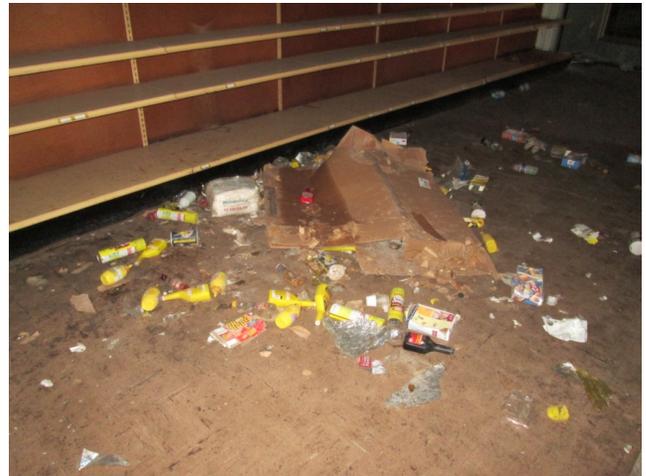
Hazard : Large quantity Solvents/Paint

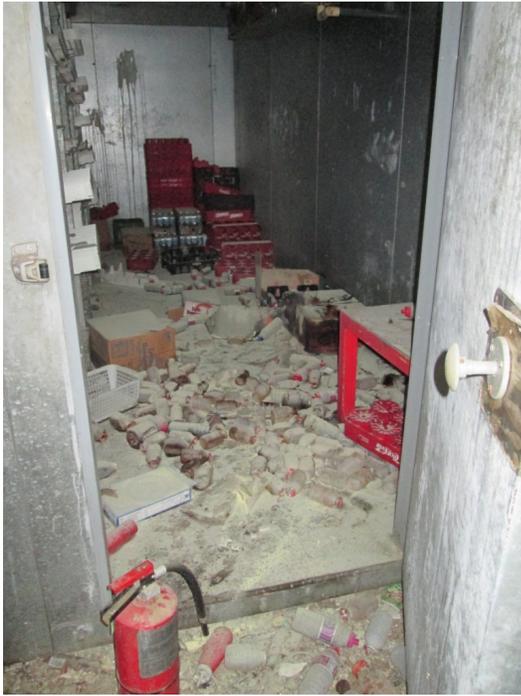
Hazard : Numerous Misc. Bottles

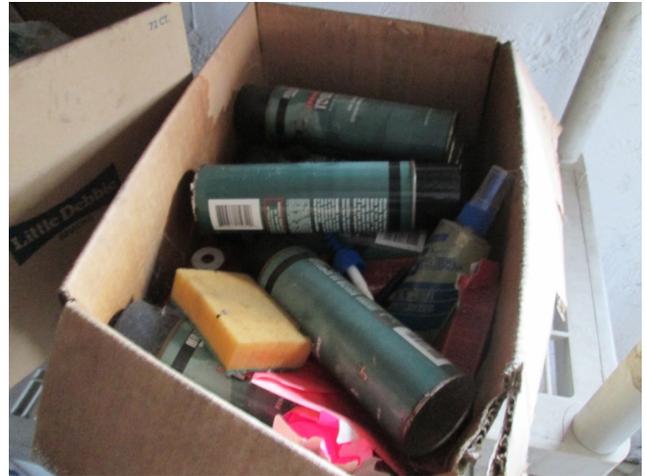
Hazard: Numerous Misc. Bottles

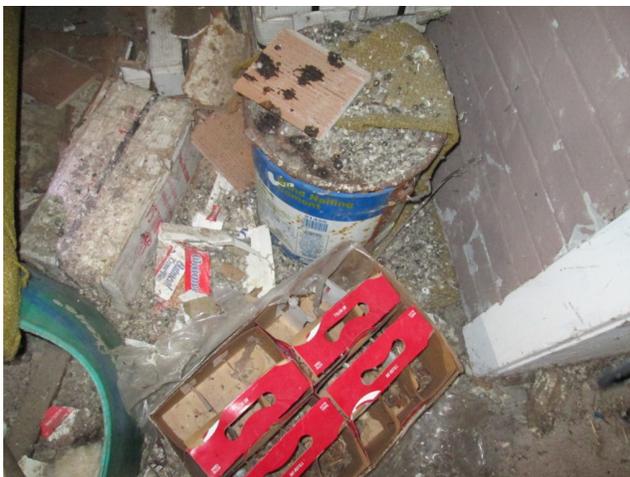
Hazard: Misc House hold items

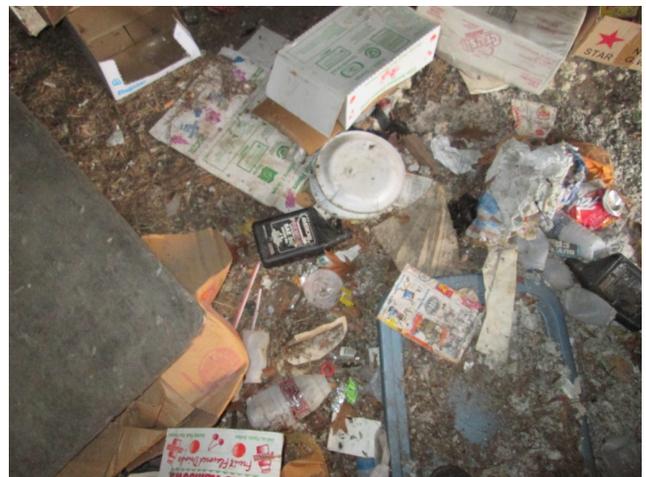
Hazard : Misc Household Items

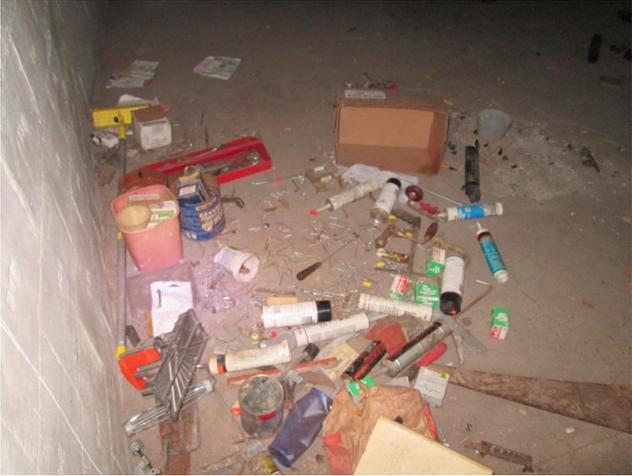
Hazard : Misc Household Items

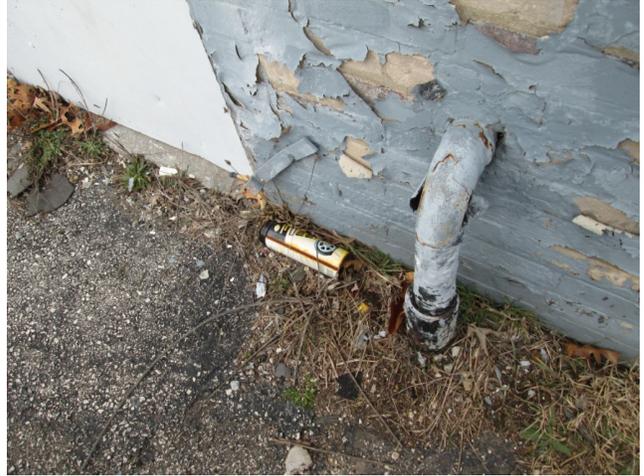
Hazard : Misc House hold items

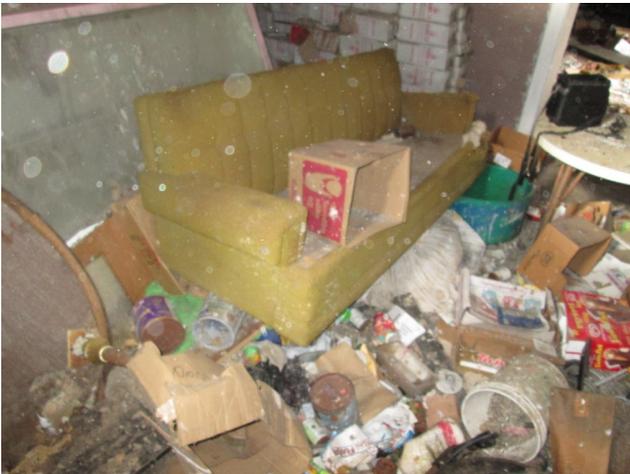
Hazard :Misc Household items

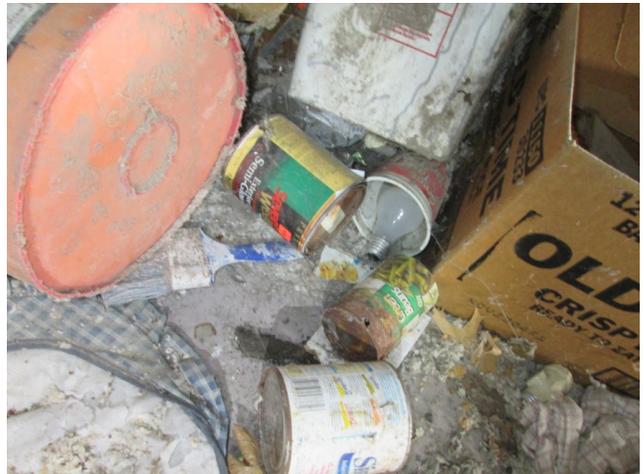
Misc: Paint/ Solvents

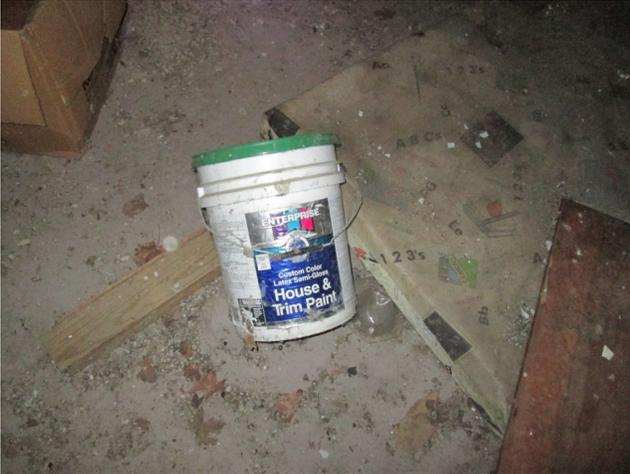
Hazard : Misc paint

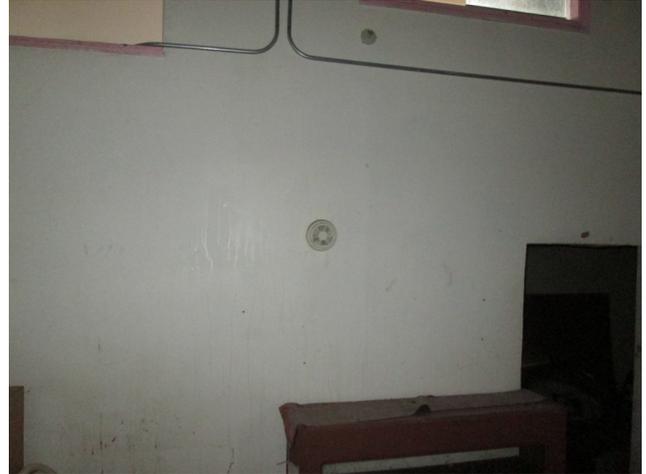
Hazard: Smoke Detector

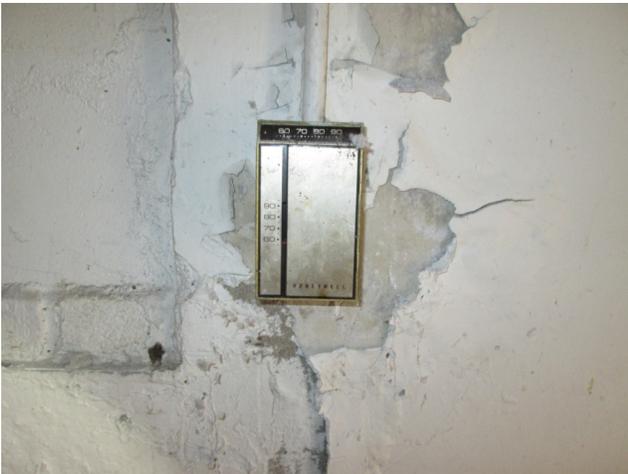
Hazard : Misc Thermostat

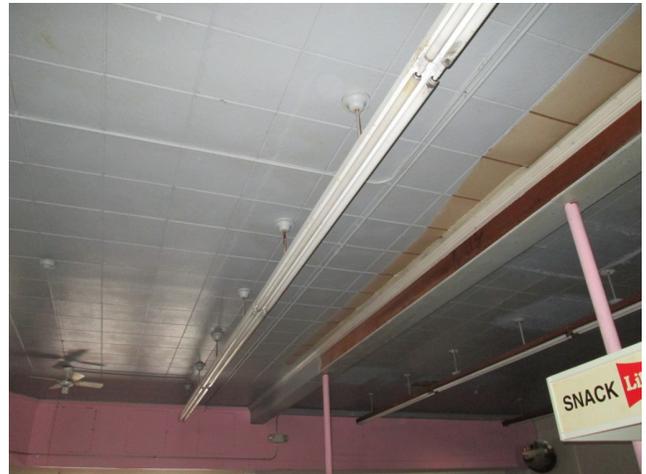
Hazard : Fluorescent Light

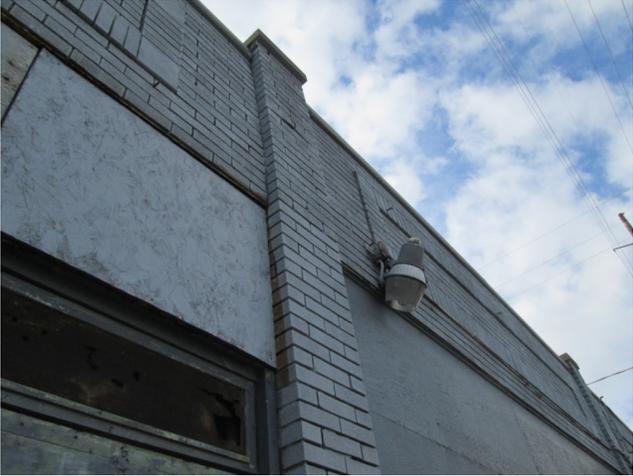
Hazard : Florescent Light

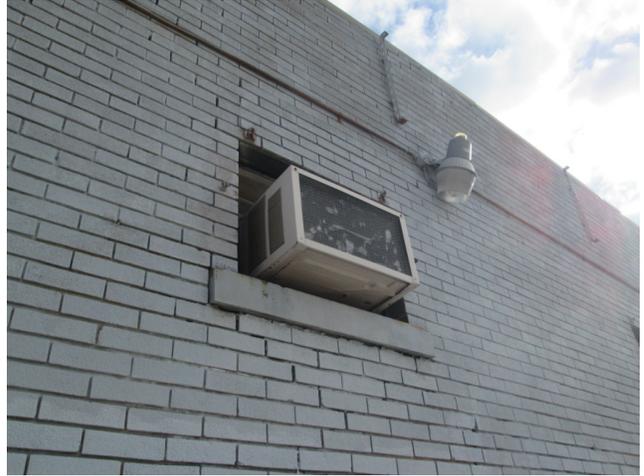
Hazard : Florescent Light

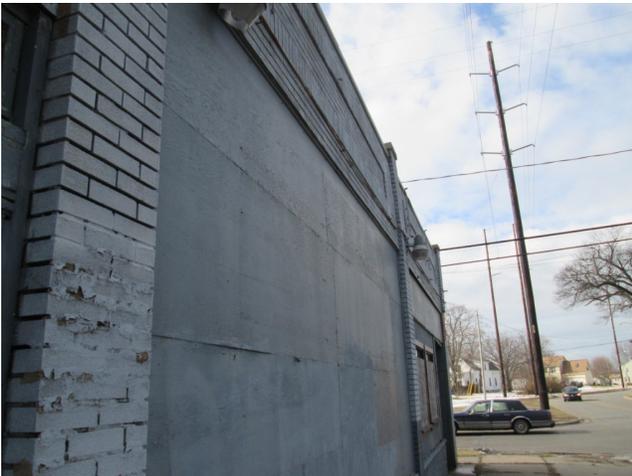
Hazard : Florescent Light

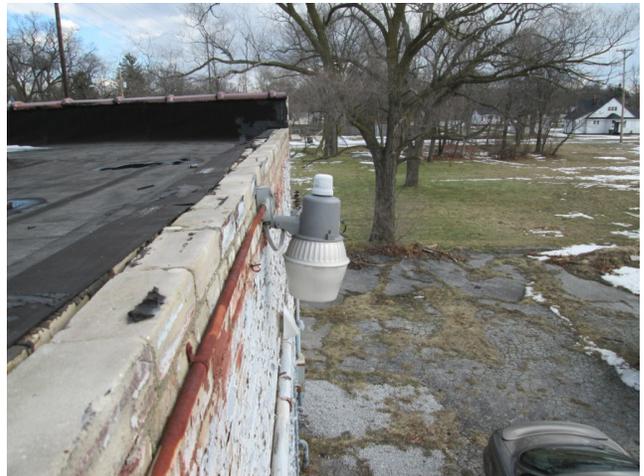
Hazard : Florescent Light

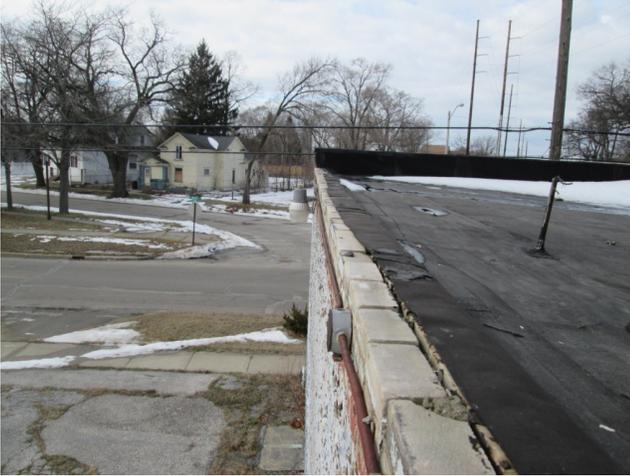
Hazard: Florescent Lights

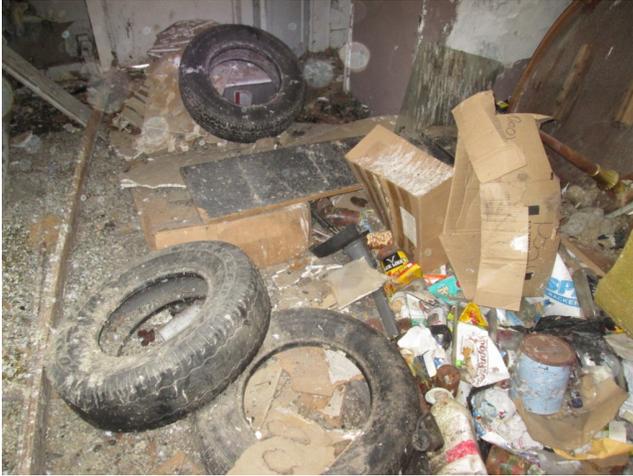
Hazard : Tires

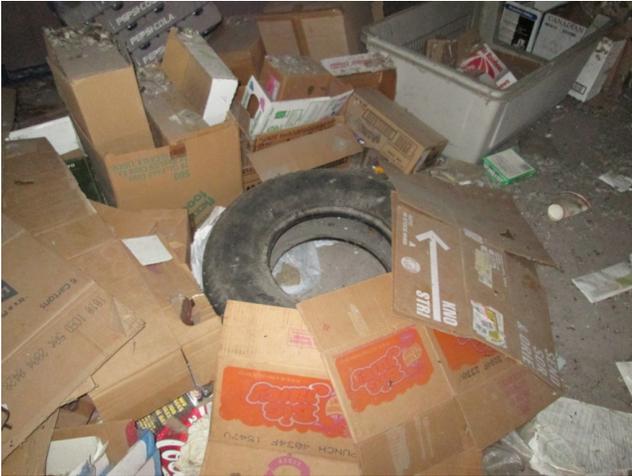
Hazard :Tires
