**NESHAP RENOVATION / DEMOLITION INSPECTION OF
ASBESTOS CONTAINING MATERIALS
AND OTHER HAZARDOUS WASTE MATERIALS
FOR THE PROPERTY KNOWN AS:**

725 Ellifson
Muskegon, MI 49441

January 25th, 2016

ETC Job #: 177234

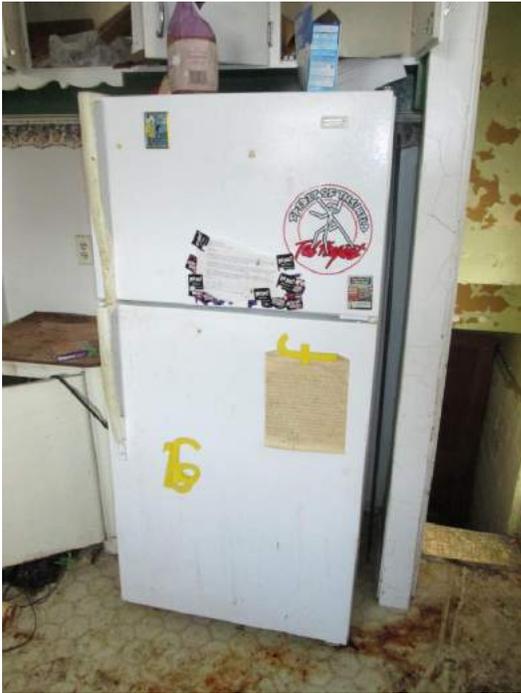
Hazard: Refrigerator (Kitchen)

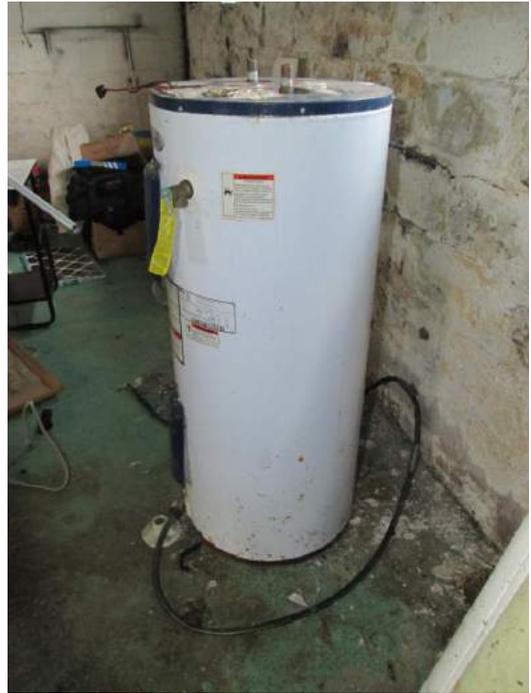
Hazard: Water Heater (Basement 9)

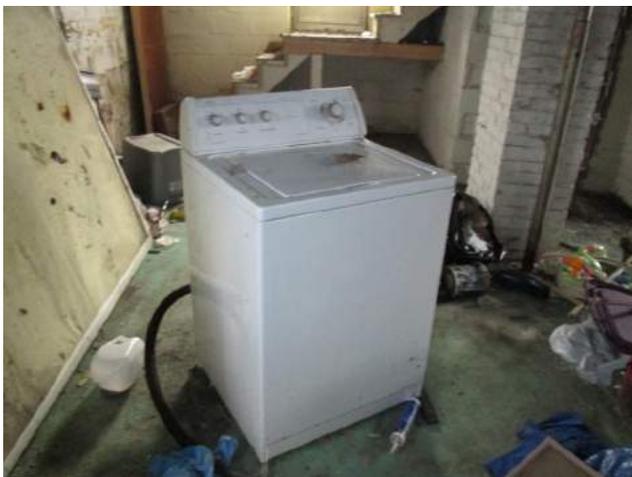
Hazard: Dryer (Basement 9)

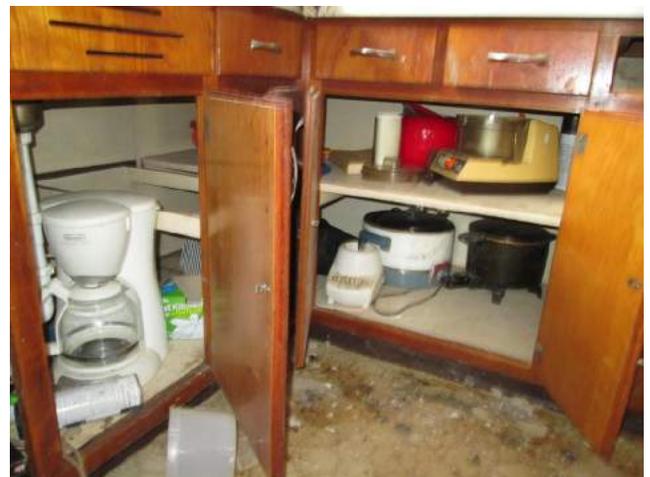
Hazard : Misc Electronics (1) (Kitchen 7)

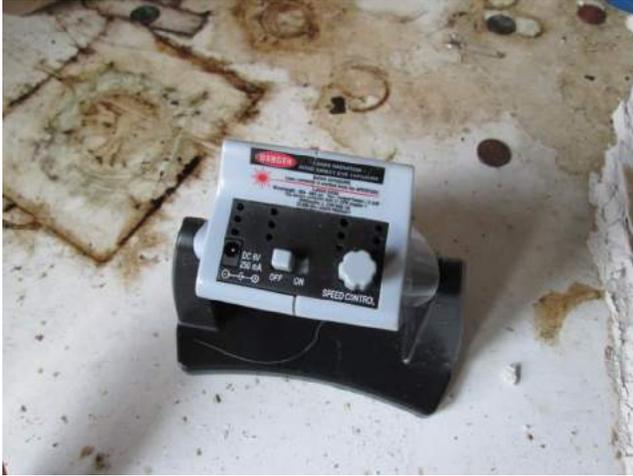
Hazard : Misc Electronics (2) (Garage or Dining room)

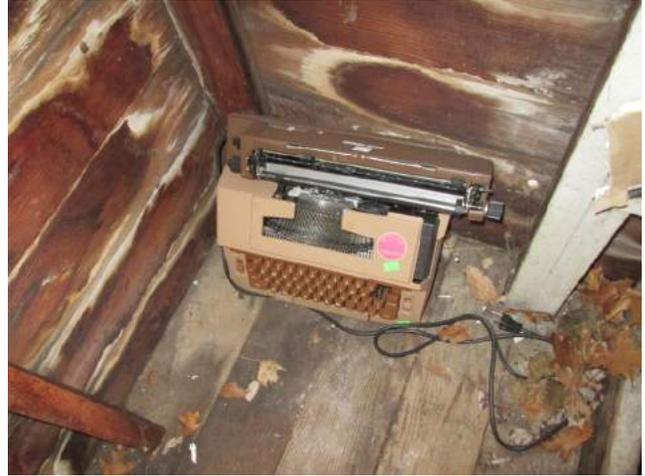
Hazard : Misc Electronics (3) (Garage or Dining room)

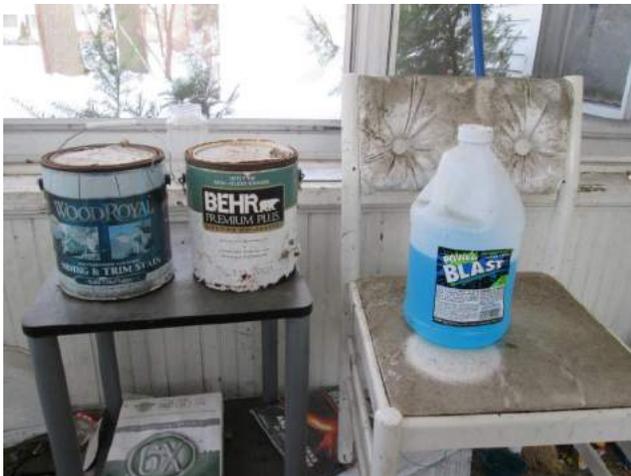
Hazard: Anti-freeze/Paint (Rooms 1 and 12)

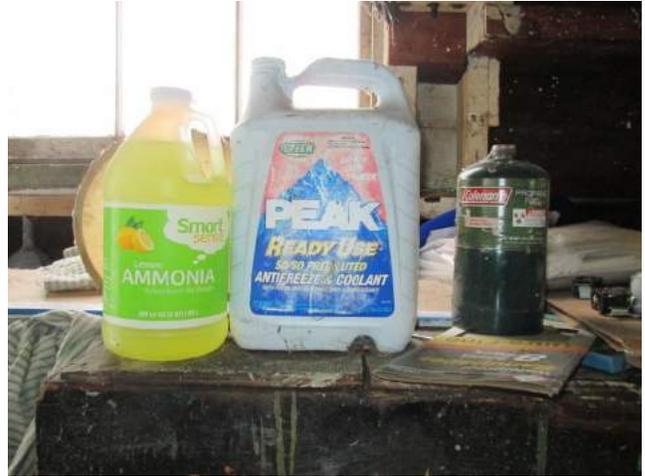
Hazard: Misc Solvents, Auto Fluid. Propane tank. (Rooms 1 and 12)

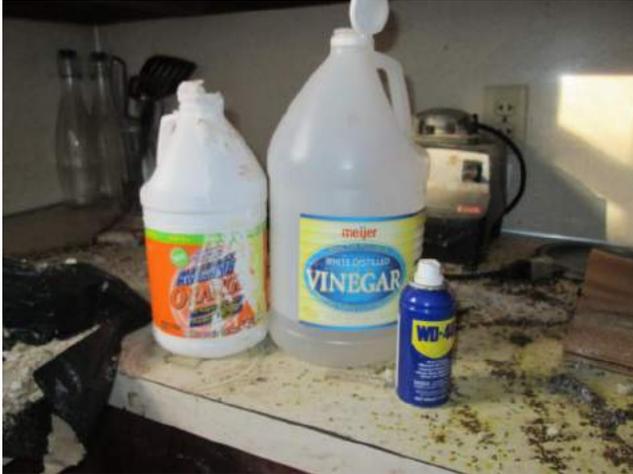
Hazards: Aerosol, Vinegar, washing fluid.
(Rooms 1 and 12)

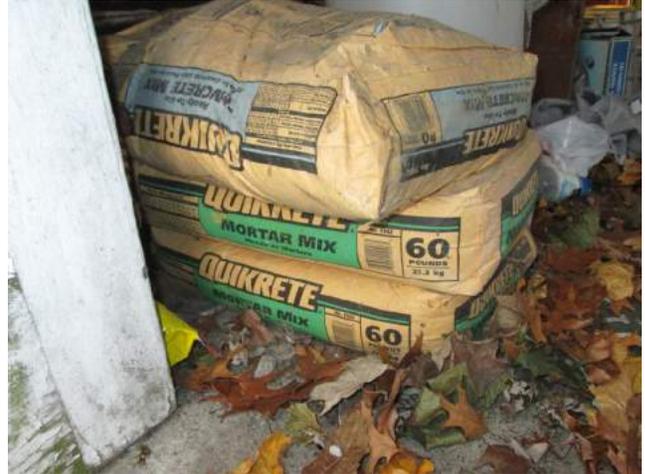
Hazard : Mortar Mix (Rooms 1 and 12)

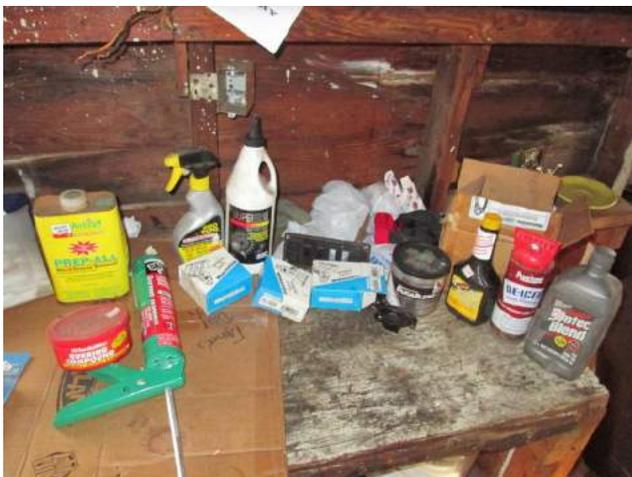
Hazards: Misc oils, caulks, aerosols,
cleaners. (Rooms 1 and 12)

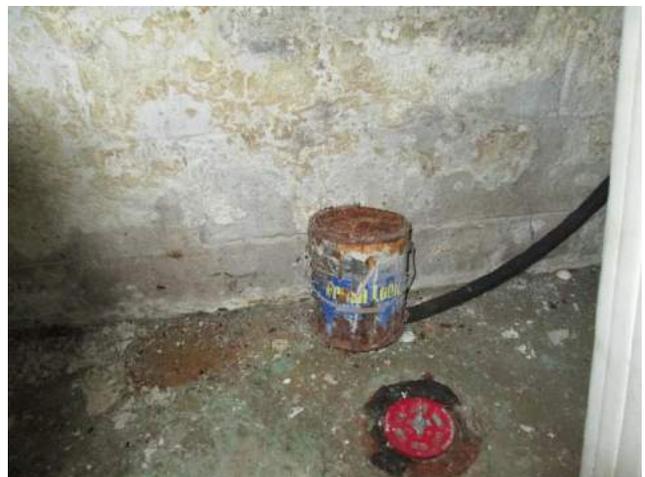
Hazard : Corroded paint can. (Rooms 1
and 12)

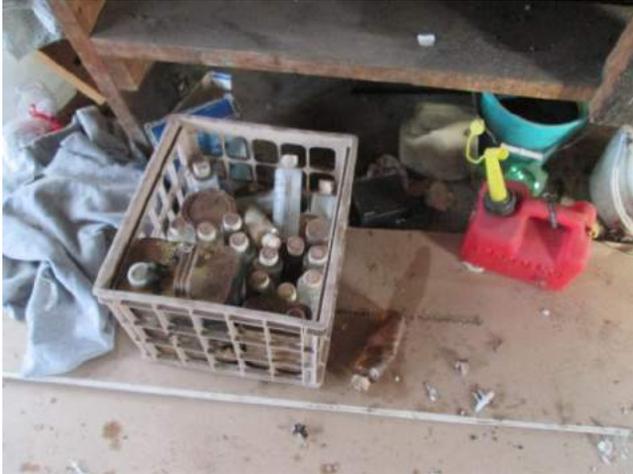
Hazard : Gas can, Misc bottles. (Rooms 1 and 12)

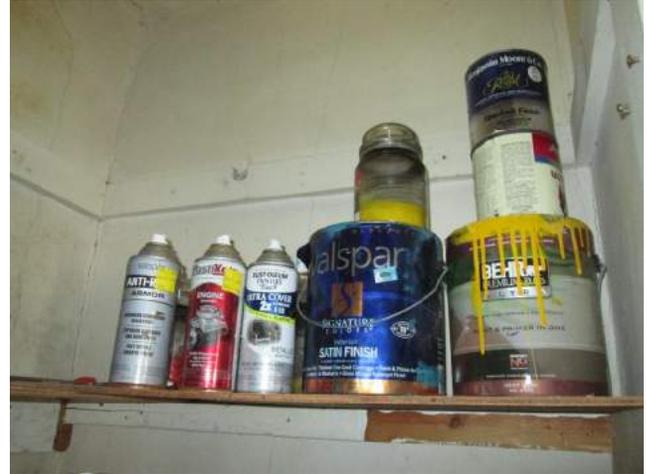
Hazard: Paint cans and Aerosol. (Rooms 1 and 12)

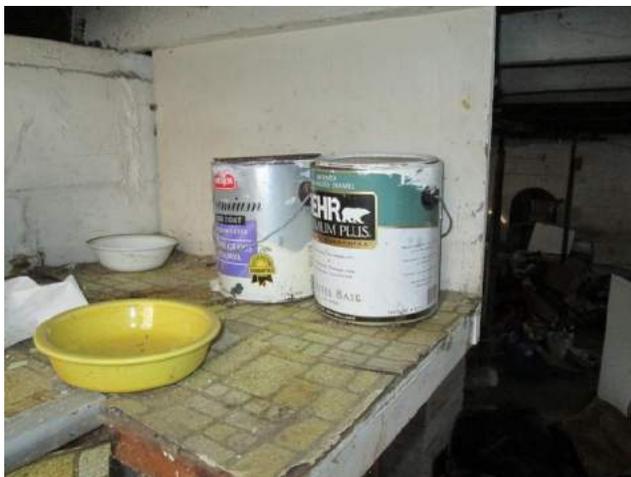
Hazard: Paint can's (Rooms 1 and 12)

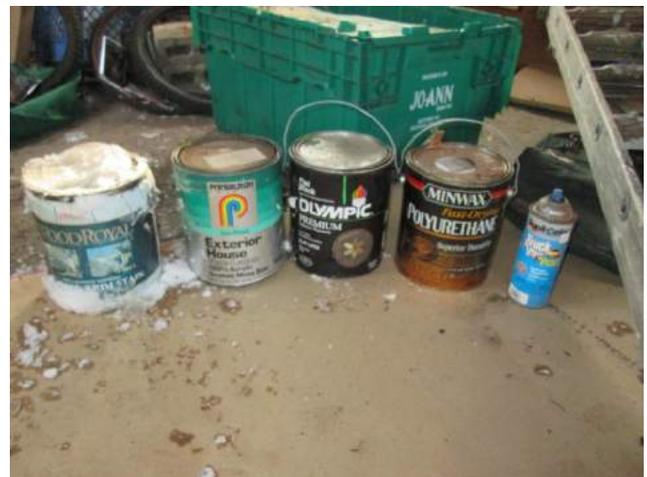
Hazard: Paint Can's and Aerosols (Rooms 1 and 12)

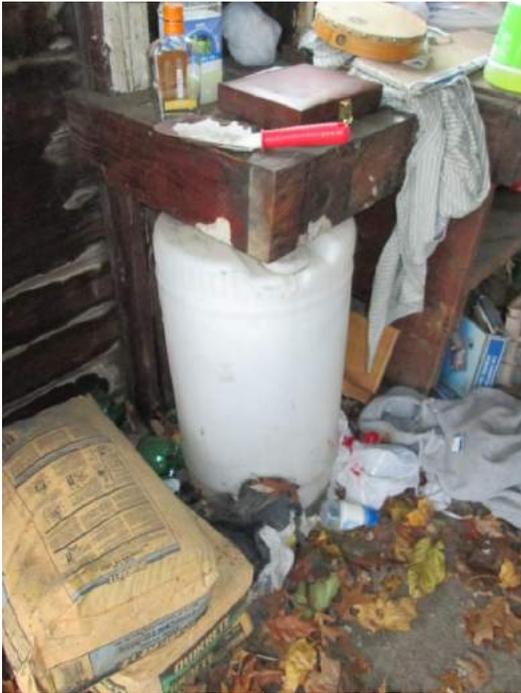
Hazard: Unlabeled Containers (Room 12)

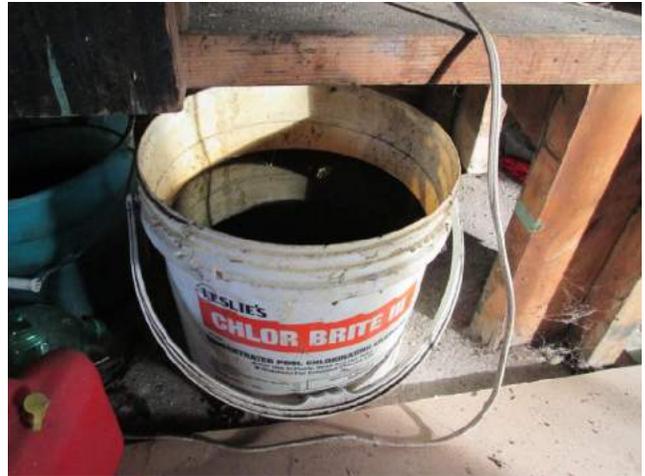
Hazard: Unlabeled Containers (2) (Room 12)

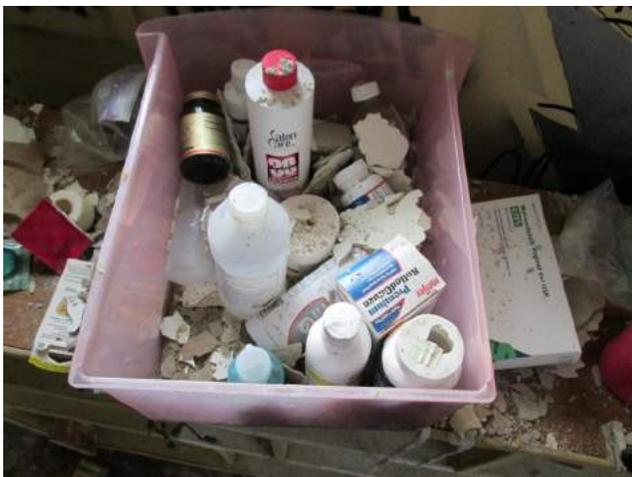
Hazards : Box of Misc. Medications.
(Living Room 2)

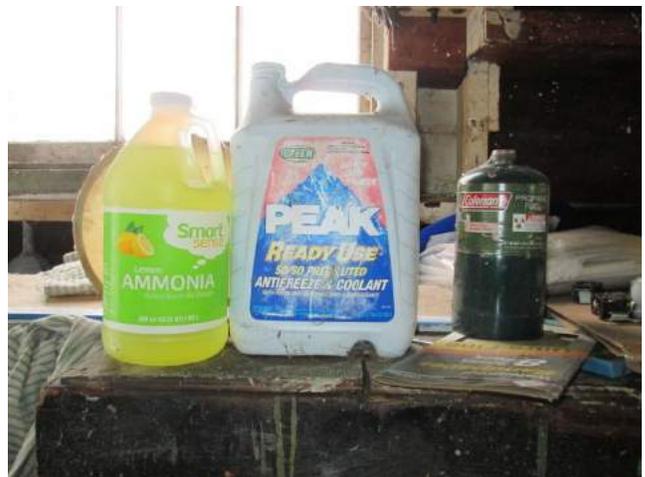
Hazard : Propane Fuel Can's—Int. Garage
12

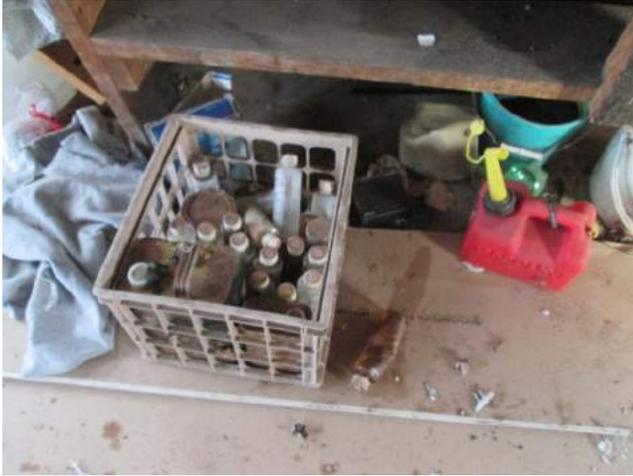
Hazard: Propane/Fuel Cans (Int. Garage 12)

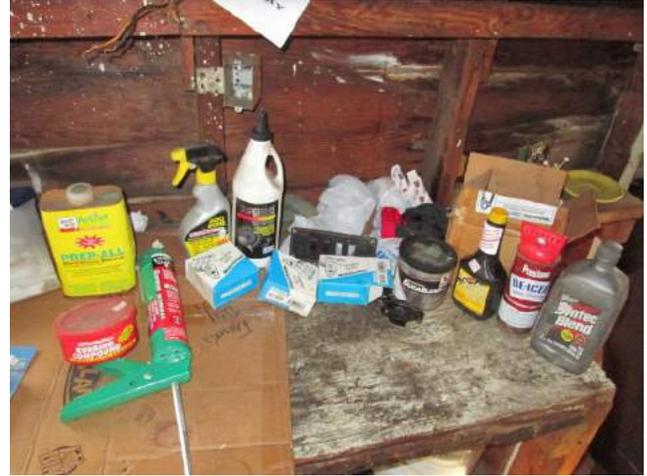
Hazard: Motor Oil, and Misc Auto Fluids. (Int Garage 12)
