Harvey Booster Station Pump #2 Rebuild Addenda - 9/9/2020

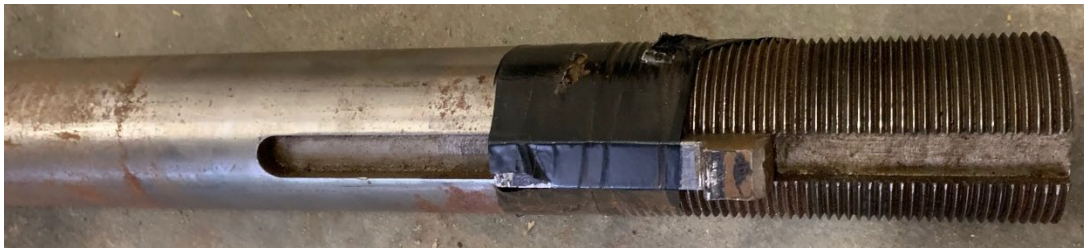
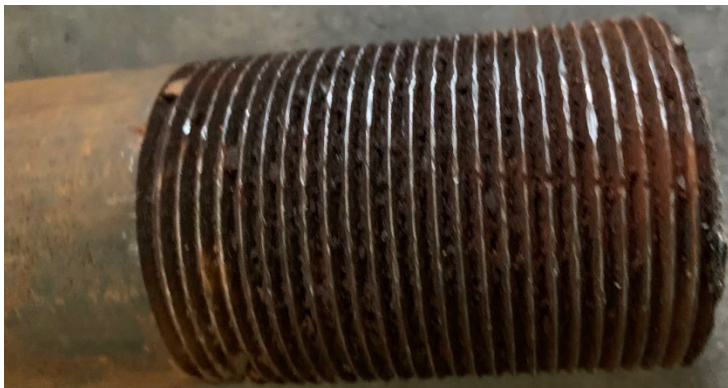
Each end of the motor drive shaft shaft.

- Information on the pump and motor shafts is in the inspection report. Per the inspection report, the motor drive shaft is in good shape and can be reused. Clean the motor drive shaft of grease and debris prior to install.
- The gap mentioned in the “Additional Notes” of the inspection report is part of the design of the pump and does not have to be addressed.
- True all wear surfaces on the three impellers.
- The color on the visible exterior parts of the pump head should be royal blue (or similar). The color on the non-visible portions of the pump does not need to be blue.
- The white exterior coating on the purchased pump bowls and suction bell is Carboline 891 with a vitreous enamel interior coating. These will not need additional coatings.
- Pre-bid meeting attendees: Kennedy Industries, Fluid Process Equipment, Peerless Midwest, Northern Pump & Well, and KSB Dubric.
